MILLENNIUM BULK TERMINALS—LONGVIEW SEPA ENVIRONMENTAL IMPACT STATEMENT

SEPA VEGETATION TECHNICAL REPORT

April 2016

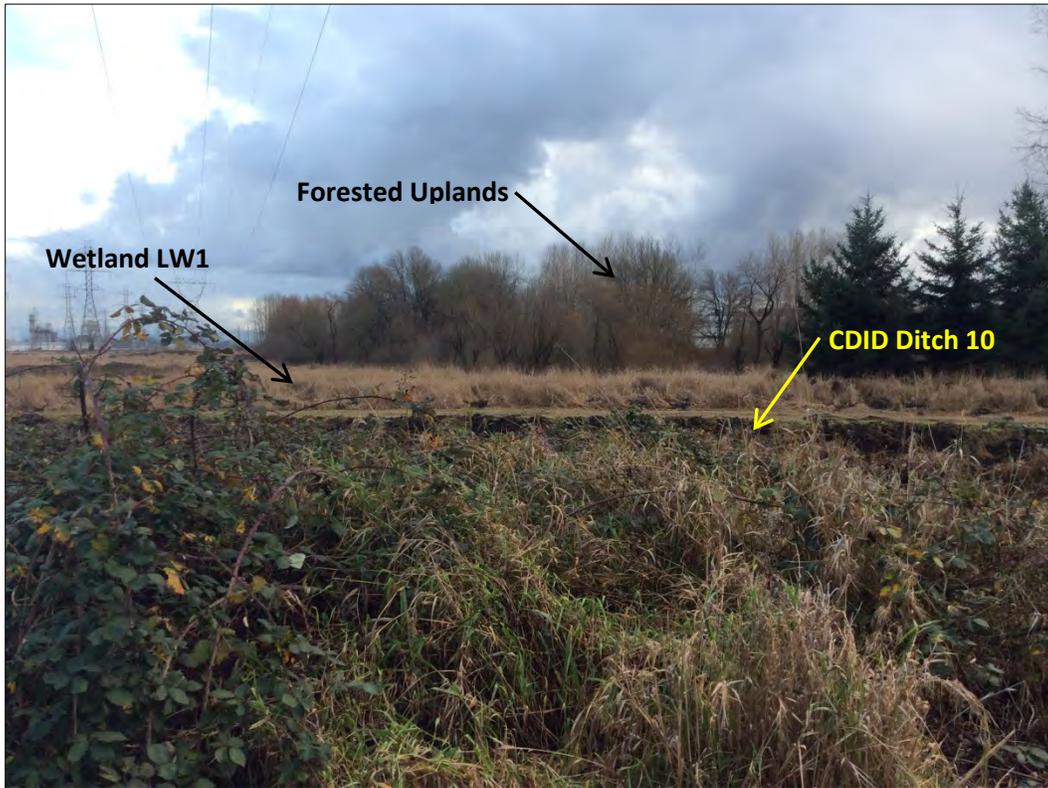
Photo 1. Photo shows typical vegetation present on Parcel 10213 of the MBTL Site including reed canarygrass and Himalayan blackberry growing in upland areas along CDID Ditch 10 and Memorial Park Drive, reed canarygrass in Wetland LW1, and forested uplands. (Photo Date: 12/12/2014)

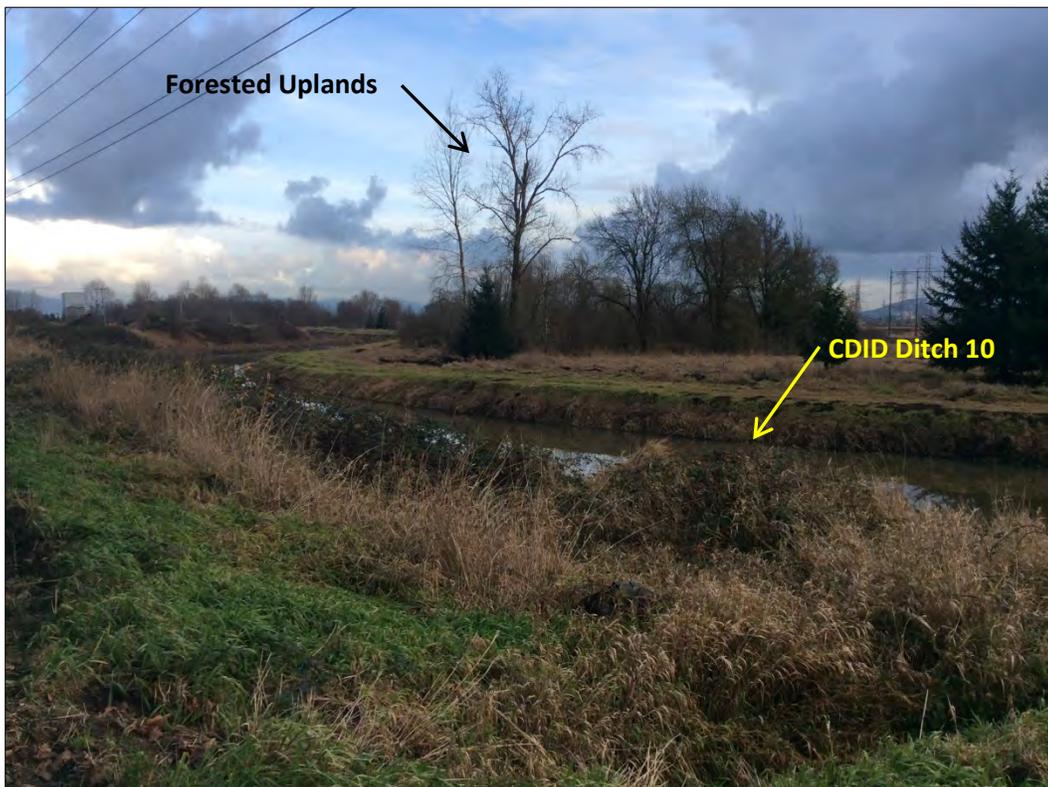
Photo 2. Photo shows typical vegetation on Parcel 10213 of the MBTL Site including reed canarygrass and Himalayan blackberry growing in upland areas around CDID Ditch 10 and forested upland areas. (Photo Date: 12/12/2014)

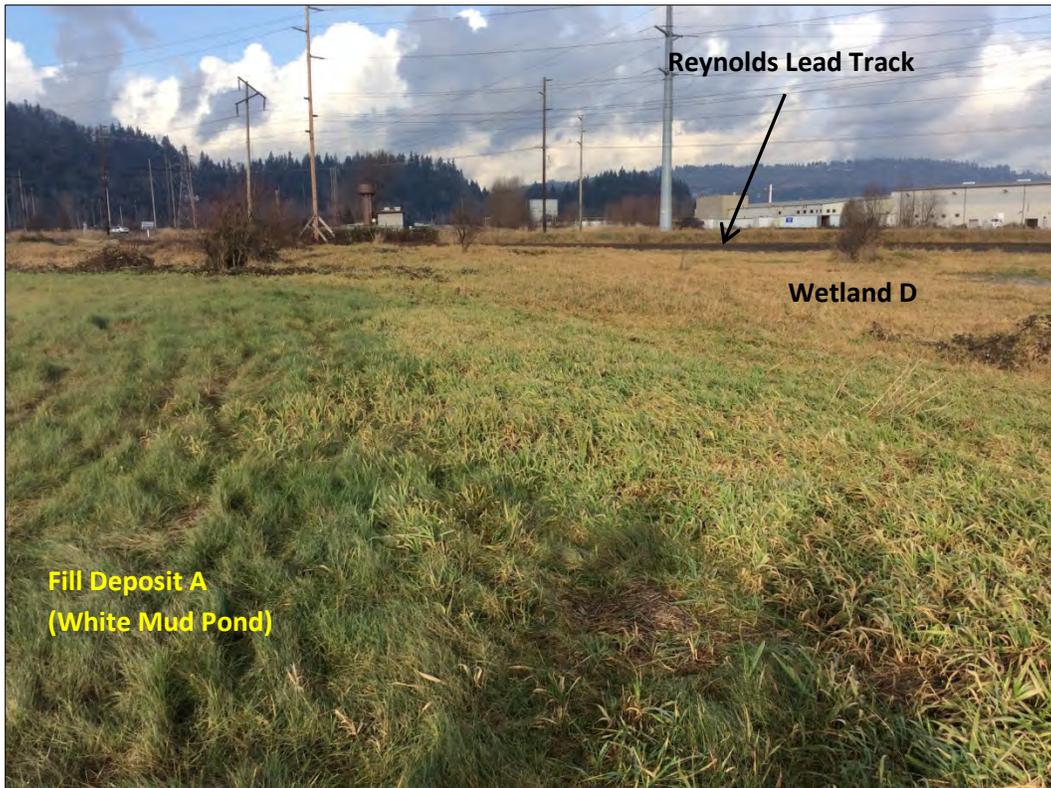
Photo 3. Photo shows herbaceous wetland vegetation cover type in Wetland D between Fill Deposit A (White Mud Pond) and Reynolds Lead Track on the MBTL site. (Photo Date: 12/12/2014)

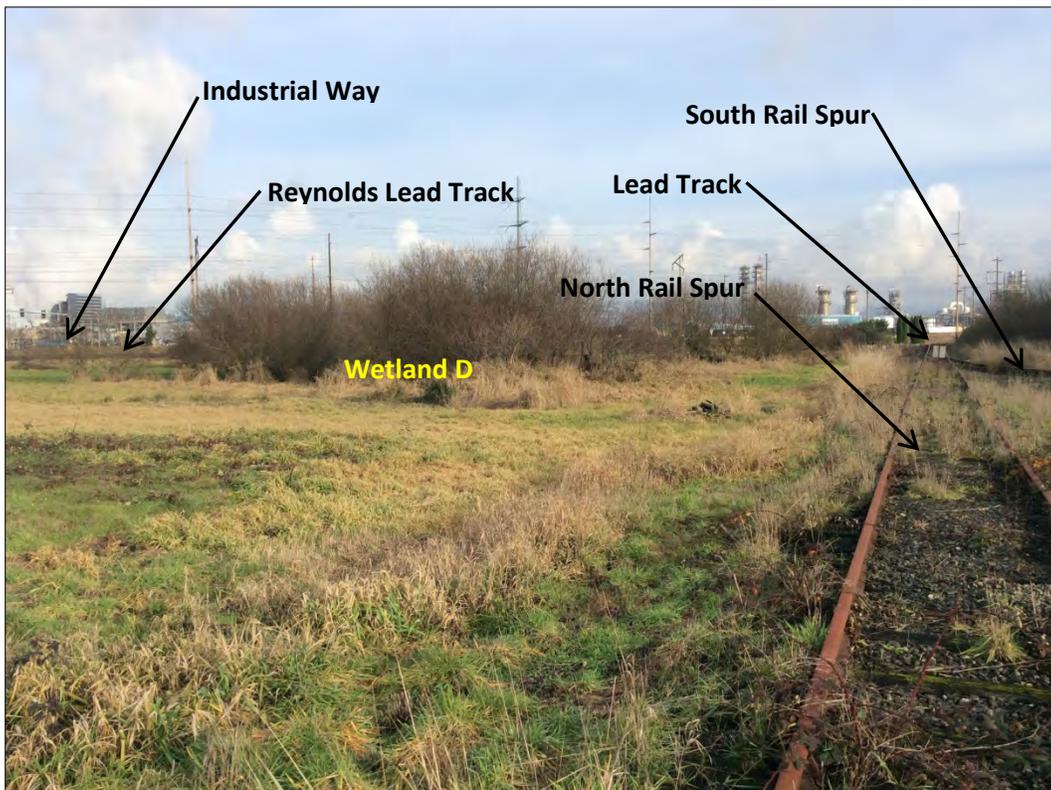
Photo 4. Photo shows scrub-shrub and herbaceous wetland vegetation cover types of Wetland D on the MBTL Site. (Photo Date: 12/12/2014)

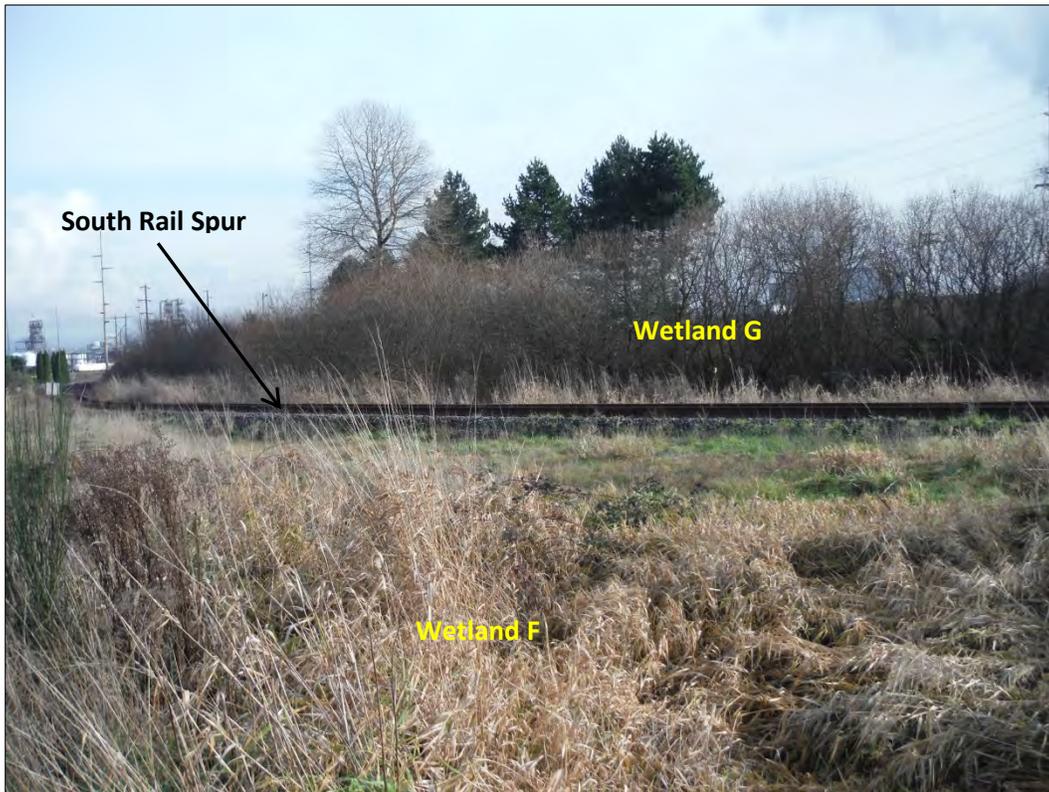
Photo 5. Photo shows herbaceous and scrub-shrub wetlands cover types in Wetlands F (foreground) and G (background) along the south rail spur on the MBTL Site. Wetland F is characterized as a disturbed wetland cover type. (Photo Date: 12/12/2014)

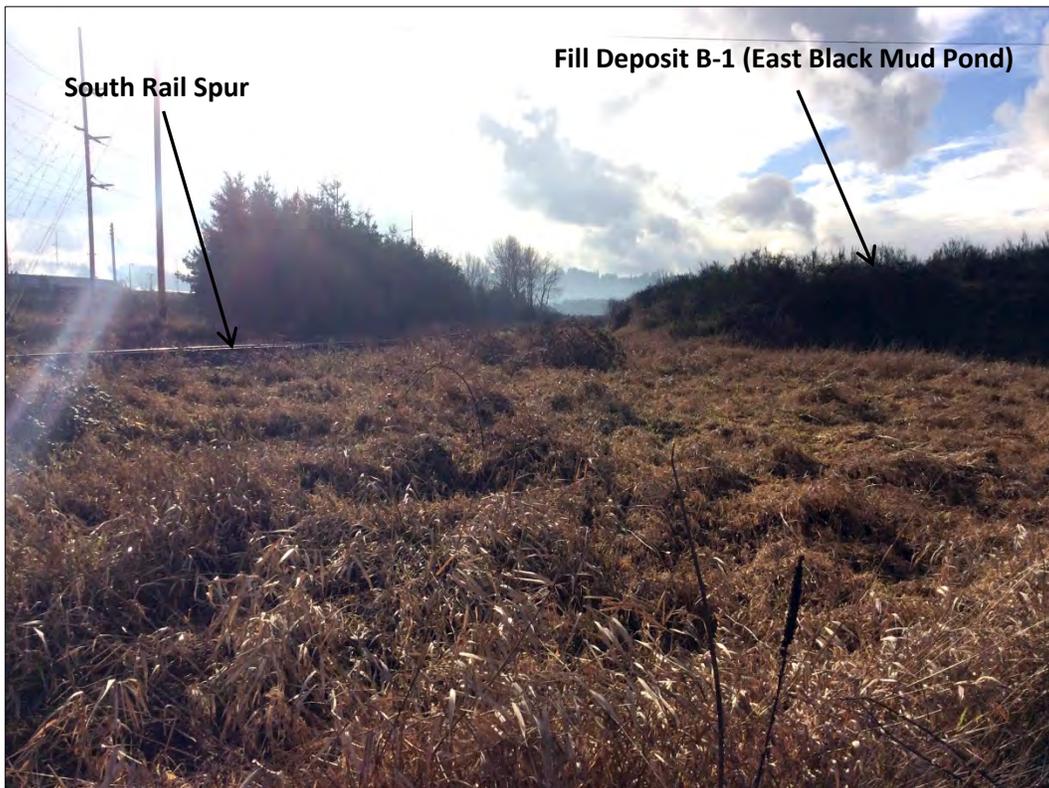
Photo 6. Photo shows typical herbaceous wetland vegetation cover type in Wetland F between the South Rail Spur and Fill Deposit B-1 (East Black Mud Pond) on the MBTL Site. Wetland F is characterized as a disturbed wetland cover type. (Photo Date: 12/12/2014)

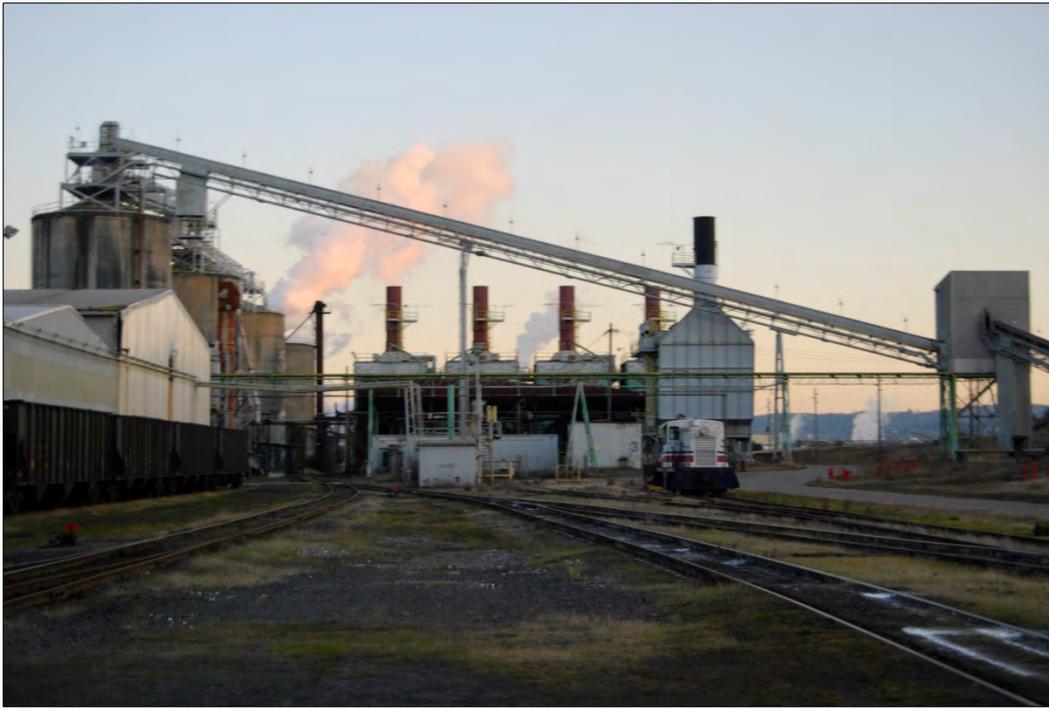
Photo 7. Photo shows disturbed cover type around the railroad tracks that extend from the South Rail Spur through the transloading area. (Photo Date: 12/4/2013)

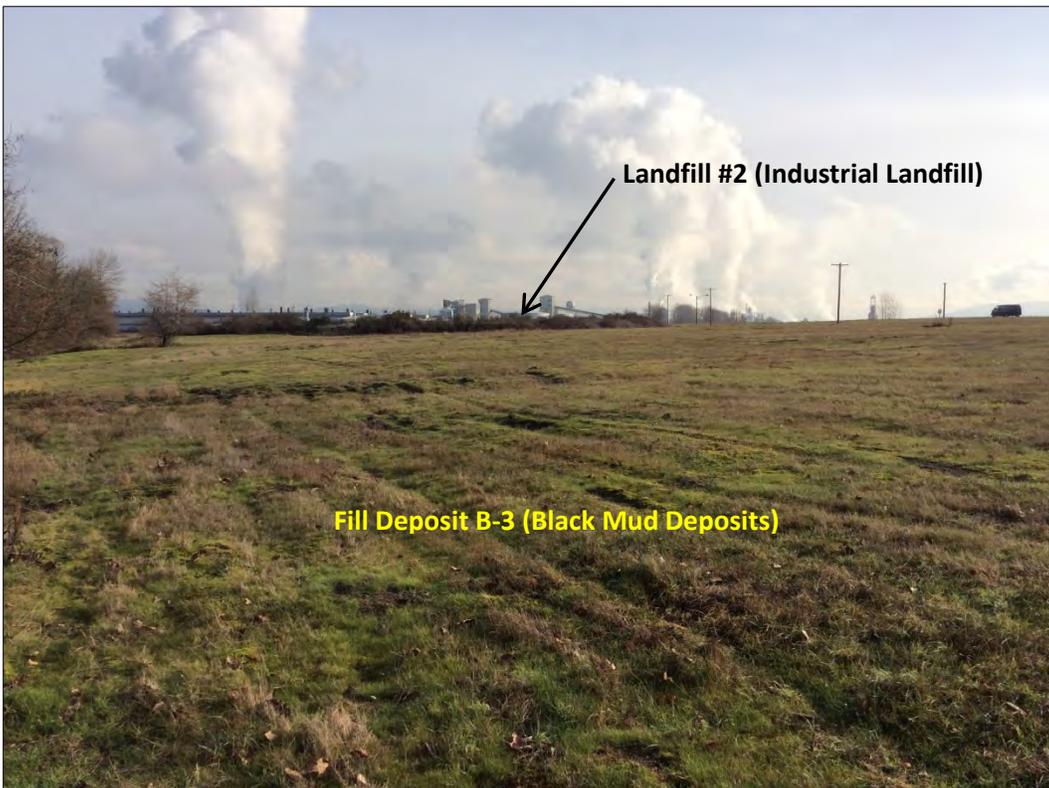
Photo 8. Photo shows typical vegetation present in Fill Deposit B-3 (Black Mud Deposits) area, which is located between the U-Ditch and CDID levee on the MBTL Site. Landfill #2 (Industrial Landfill) can be seen in the background. (Photo Date: 12/12/2014)

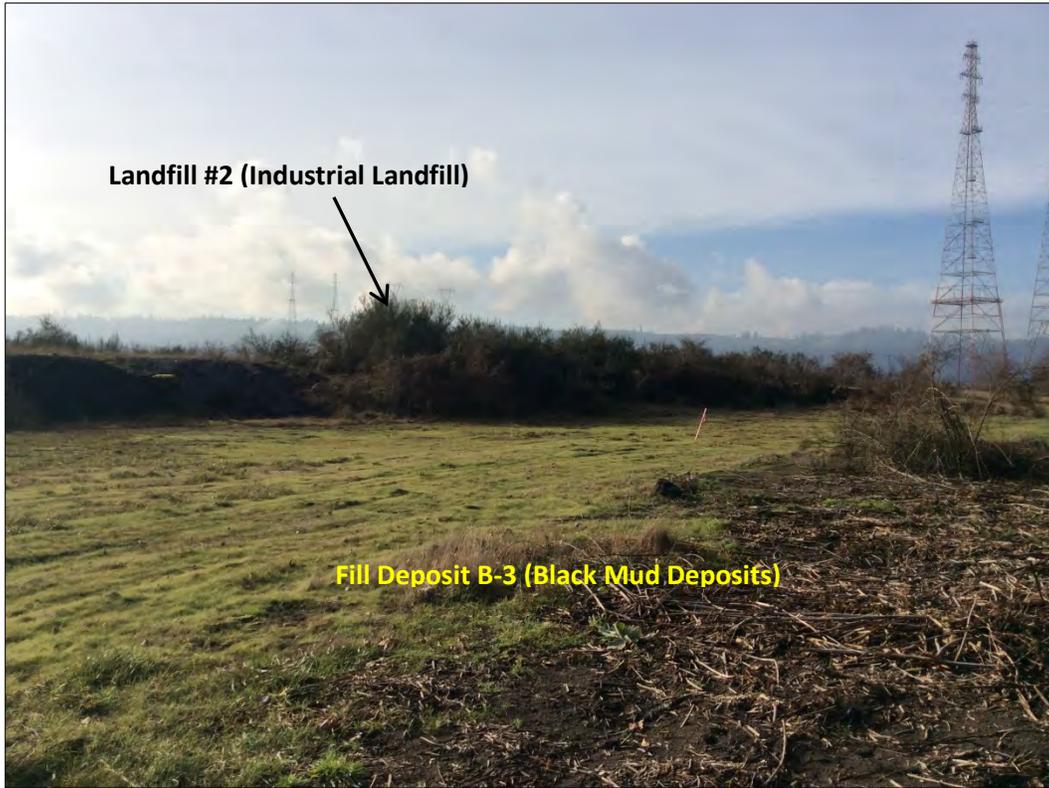
Photo 9. Photo shows typical disturbed vegetation cover type present on Landfill #2 (Industrial Landfill) and central portion of Fill Deposit B-3 (Black Mud Deposits) on the MBTL Site. (Photo Date: 12/12/2014)

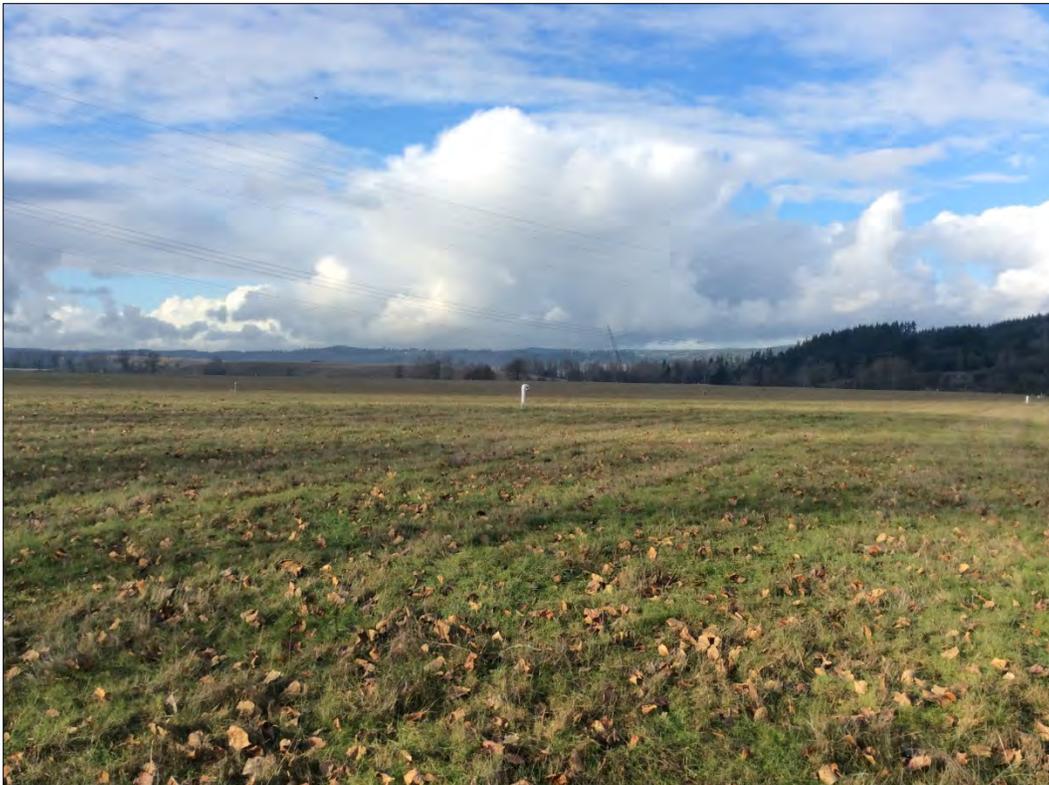
Photo 10. Photo shows managed herbaceous vegetation growing on Closed BMP Facility on the MBTL Site. This area is regularly mown. (Photo Date: 12/12/2014)

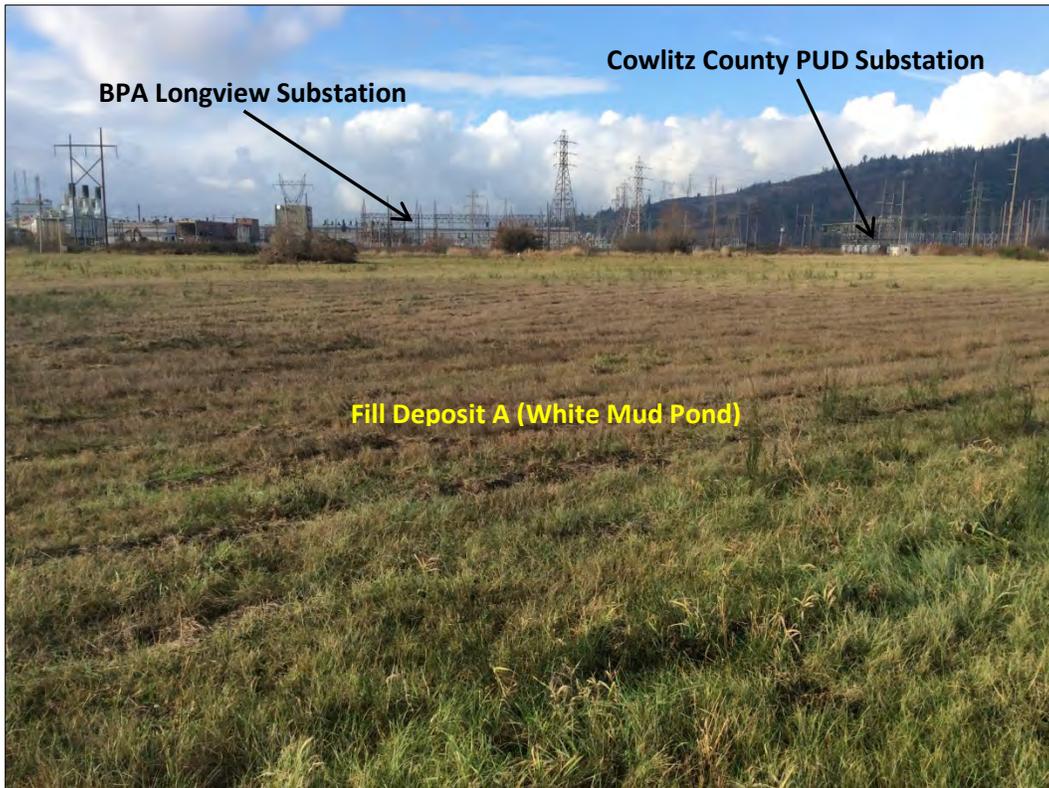
Photo 11. Photo shows typical managed vegetation cover type growing on Fill Deposit A (White Mud Pond) on the MBTL Site. (Photo Date: 12/12/2014)

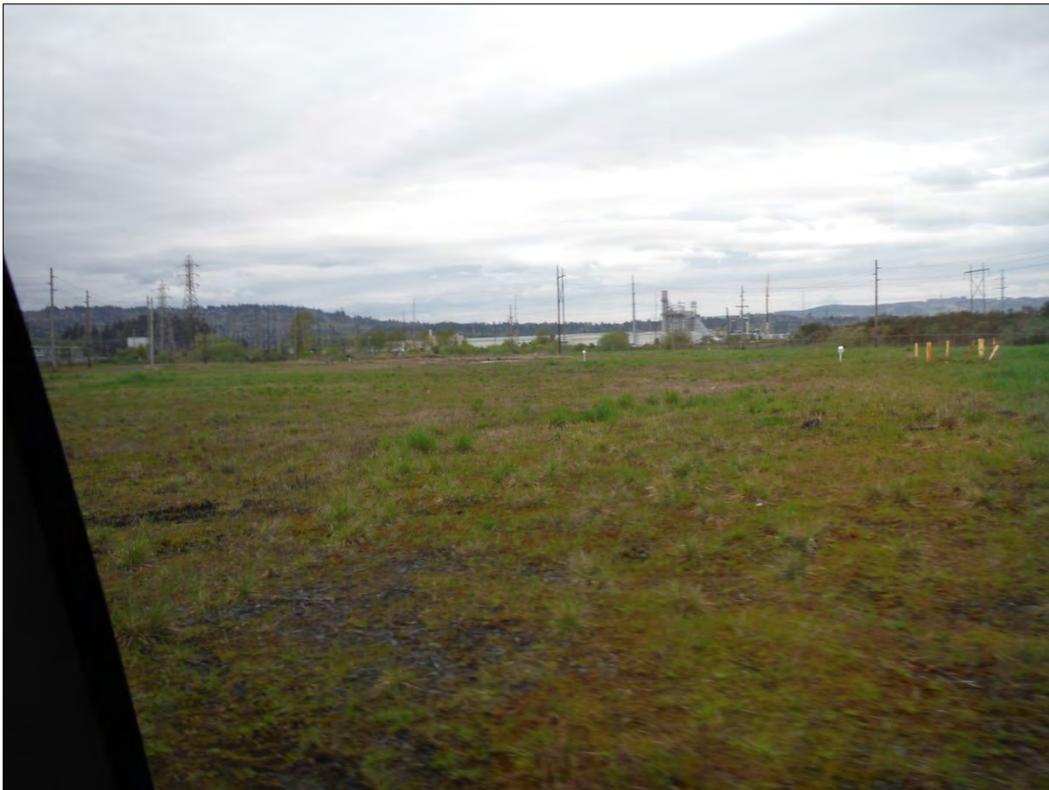
Photo 12. Photo shows managed herbaceous vegetation cover type growing on Fill Deposit B-2 (Eastern Black Mud Pond) on the MBTL Site. (Photo Date: 4/8/2014)

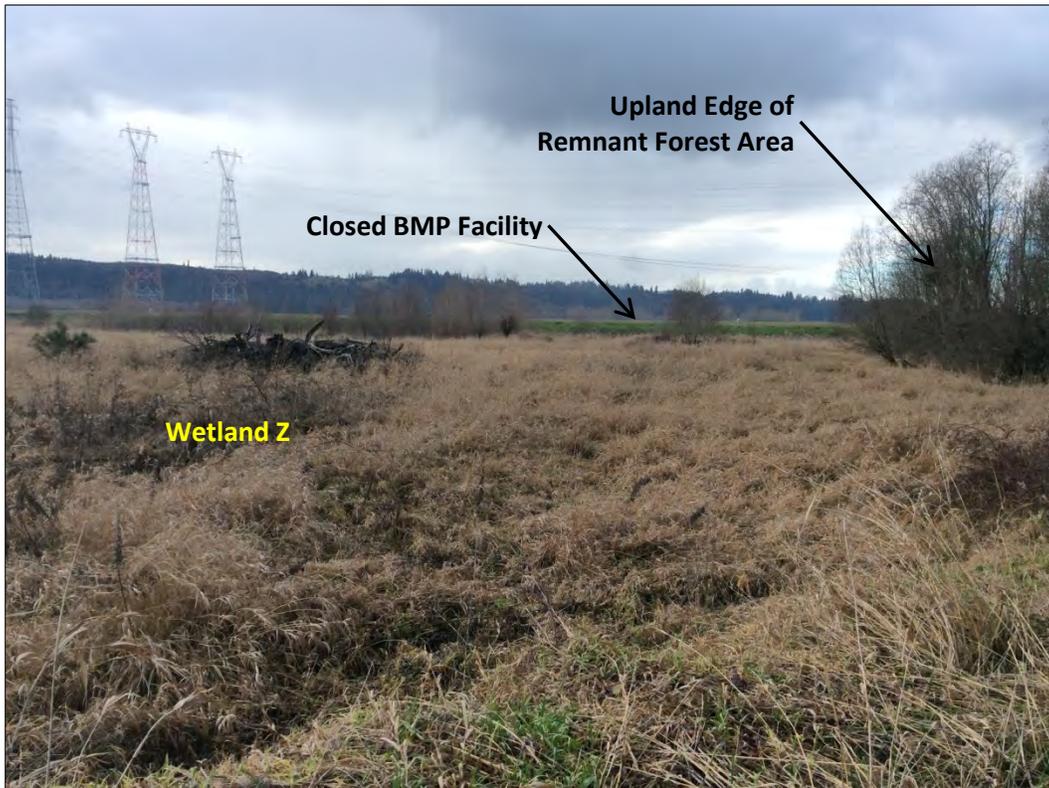
Photo 13. Photo shows typical conditions present in southern portion of the former Borrow Area located between Closed BMP Facility and Former Cable Plant on the MBTL Site. This area includes Wetland Z and a portion of Wetland C (not visible in photo), and is bordered by the upland edge of the Remnant Forest Area. (Photo Date: 12/12/2014)

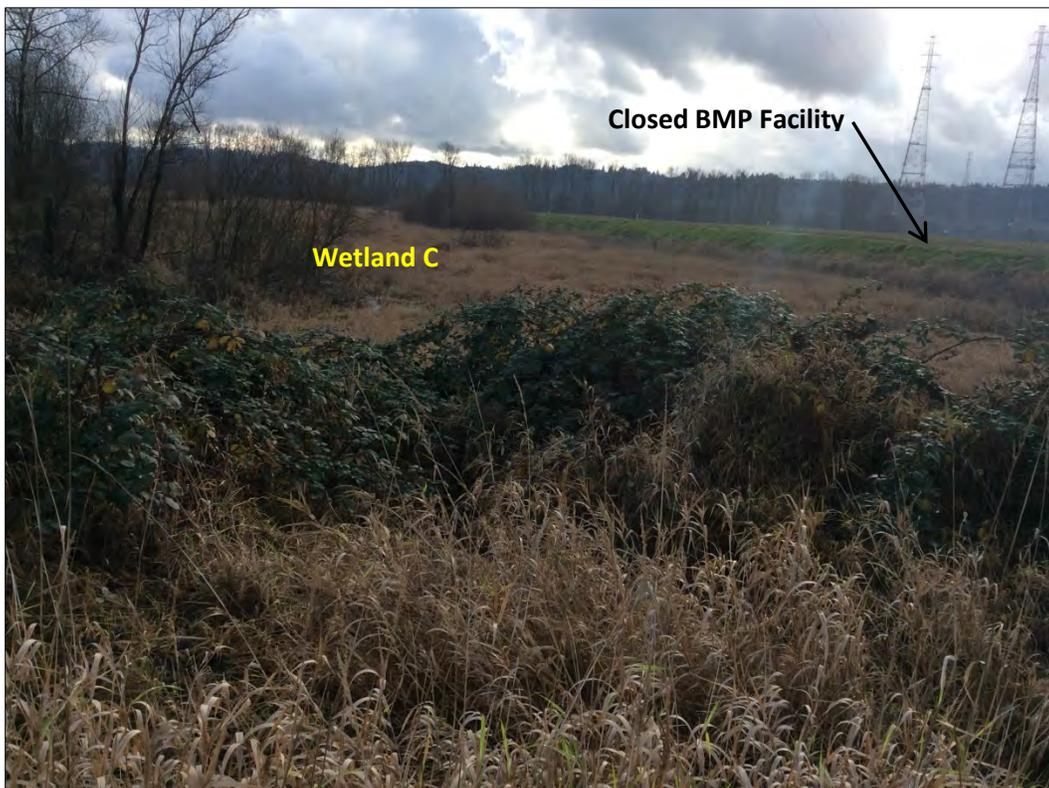
Photo 14. Photo shows northern portion of Borrow Area, which contains the herbaceous portion of Wetland C, as well as adjacent uplands dominated by reed canarygrass and Himalayan blackberry in the foreground and between the wetland and the Closed BMP Facility. (Photo Date: 12/12/2014)

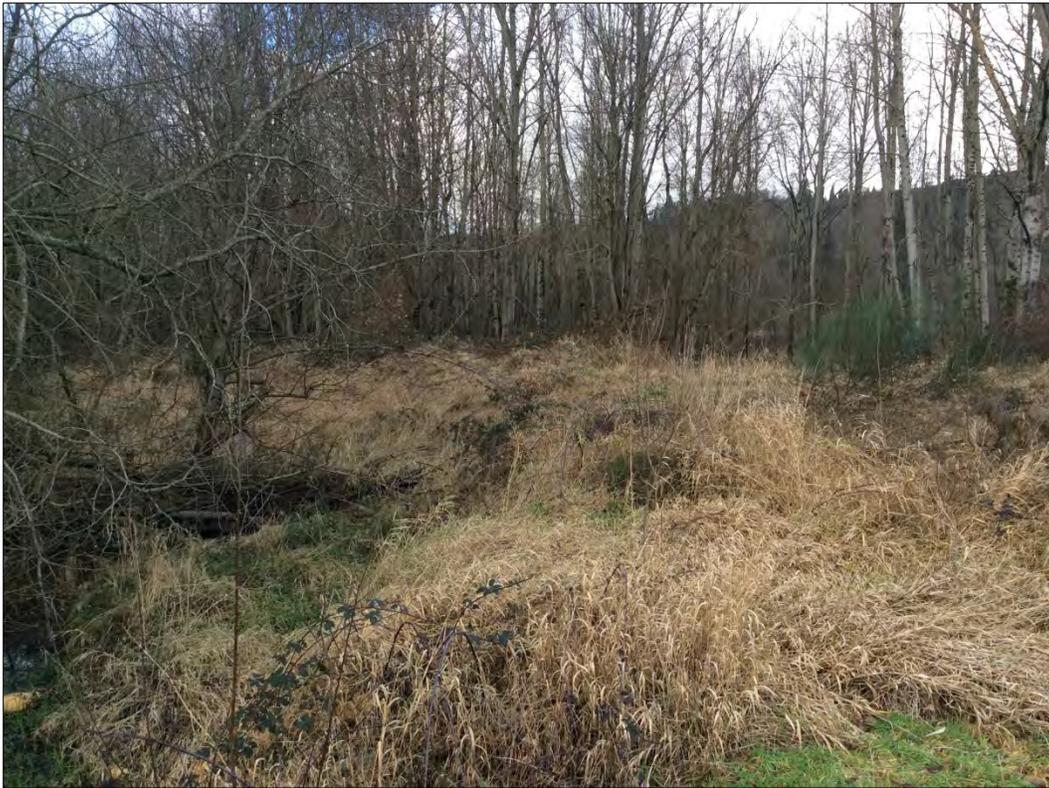
Photo 15. Photo shows typical conditions present in the Remnant Forest Area that lies between the Closed BMP Facility and Former Cable Plant on the Former Cable Plant on the MBTL Site. Most of this area consists of forested wetlands. (Photo Date: 12/12/2014)

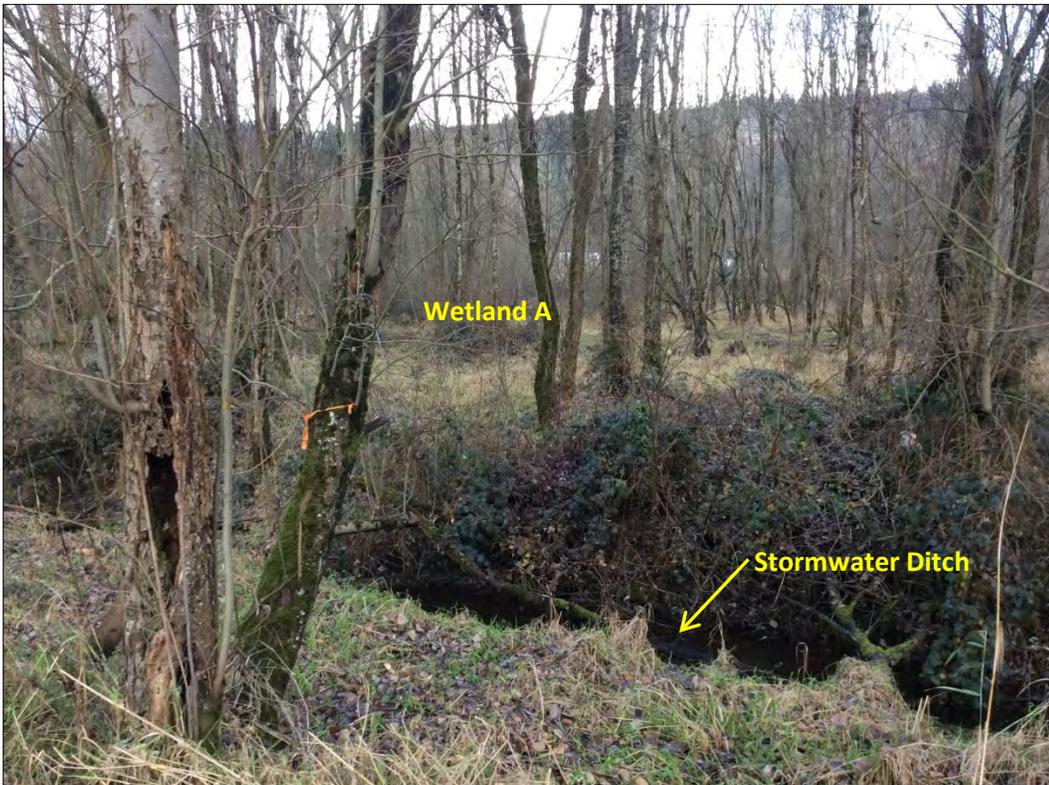
Photo 16. Photo shows Wetland A and a stormwater conveyance ditch in Remnant Forest Area on MBTL Site. (Photo Date: 12/12/2014)

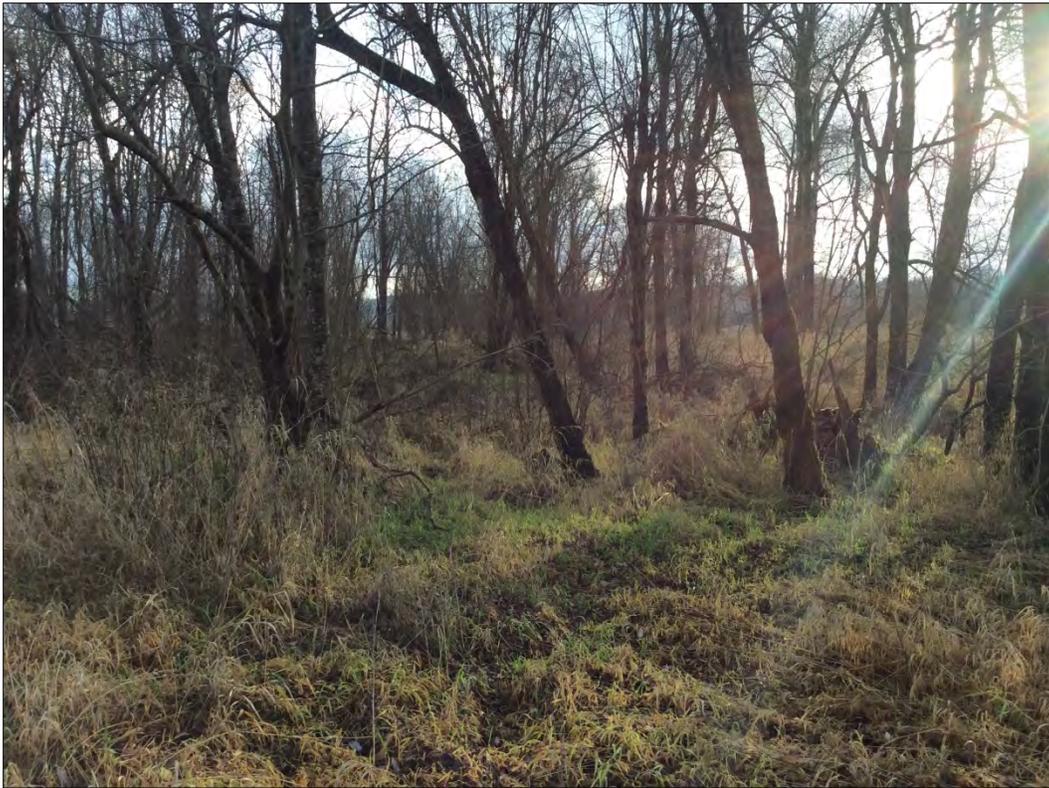
Photo 17. Photo shows forested portion of Wetland C in the Remnant Forest Area on the MBTL Site. (Photo Date: 12/12/2014)

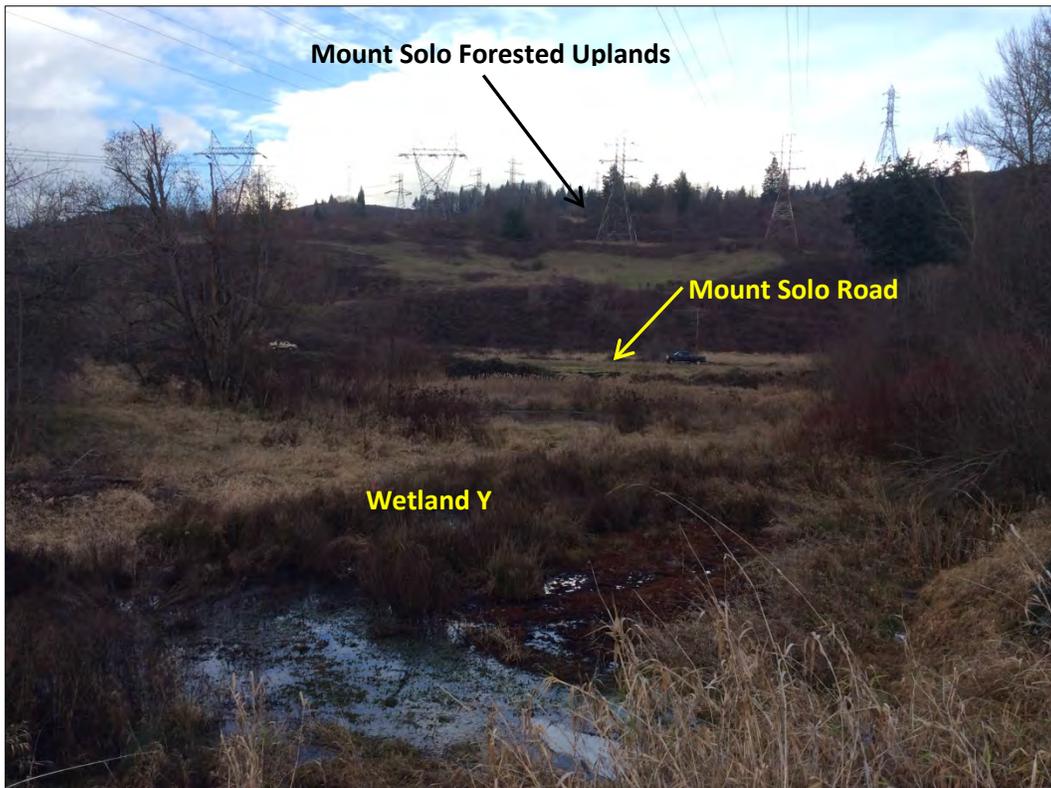
Photo 18. Photo shows the herbaceous and scrub-shrub areas of Wetland Y and surrounding upland vegetation on the MBTL Site. Some of the forested uplands on Mount Solo can be seen in the background on the other side of Mount Solo Road. (Photo Date: 12/12/2014)

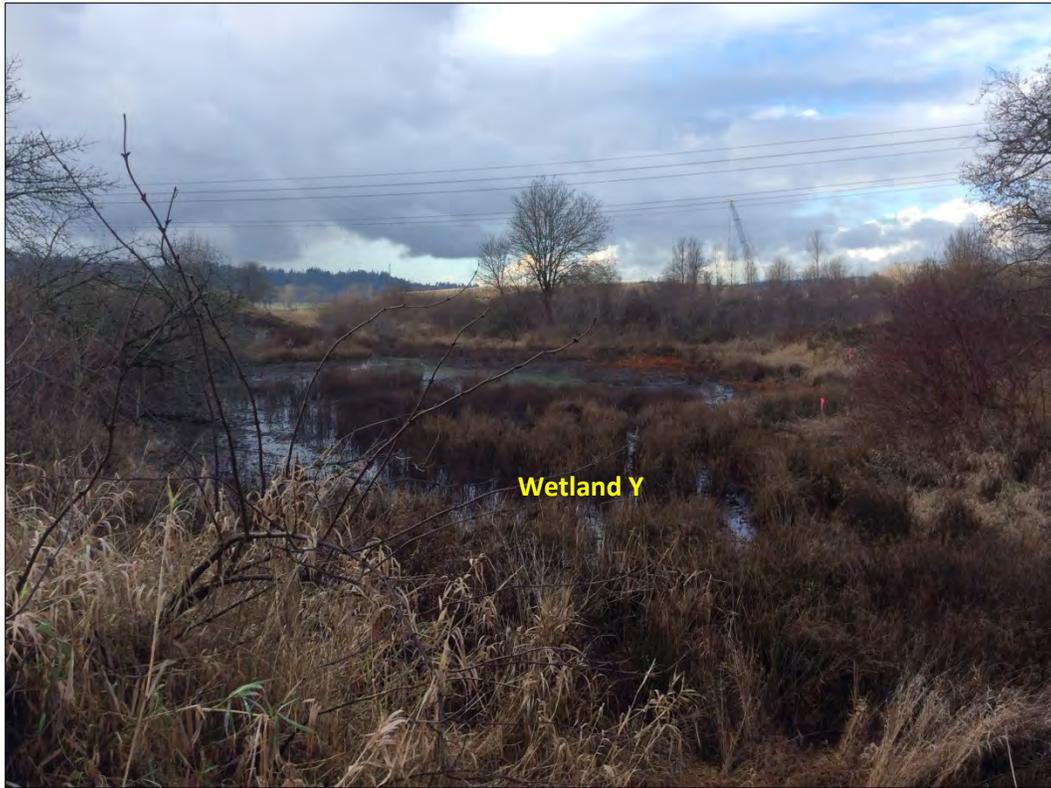
Photo 19. Photo shows typical wetland and upland vegetation cover types present in and around Wetland Y on the MBTL Site. This wetland extends onto the Barlow Point Site. (Photo Date: 12/12/2014)

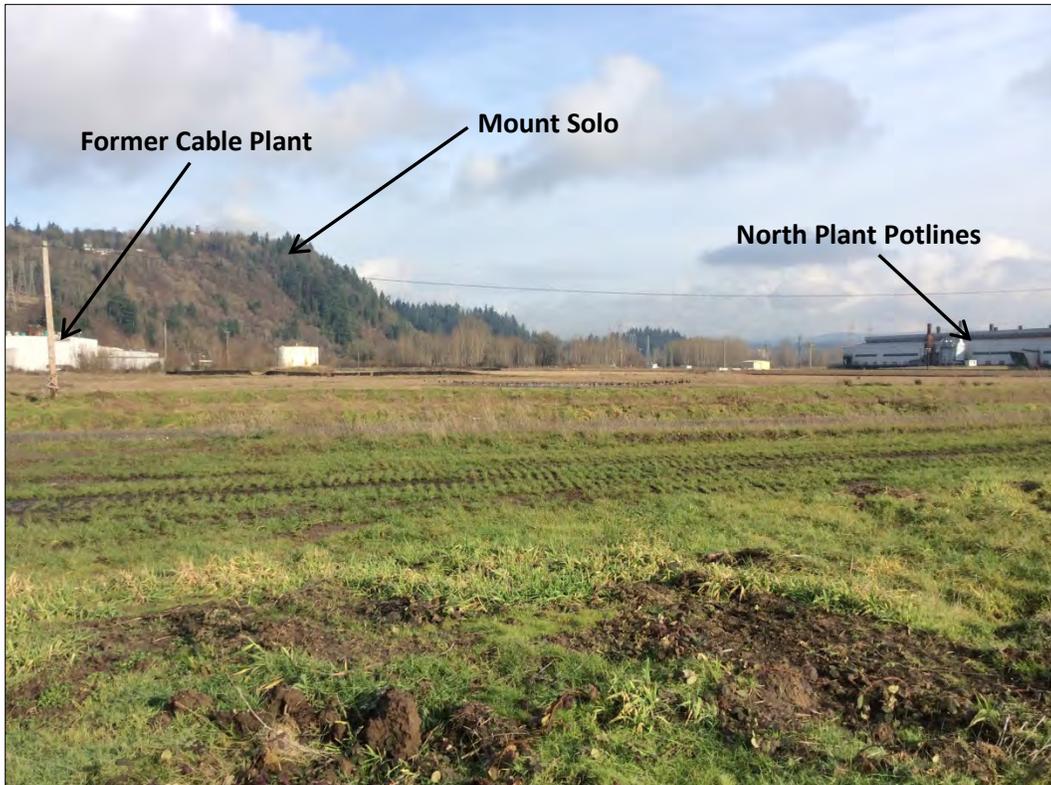
Photo 20. Photo shows typical disturbed vegetation cover type in southern portion of Outdoor Storage Area between the Cable Plant and North Plant Potlines on the MBTL Site. Upland forested areas on Mount Solo are visible in the background (Photo Date: 12/12/2014)

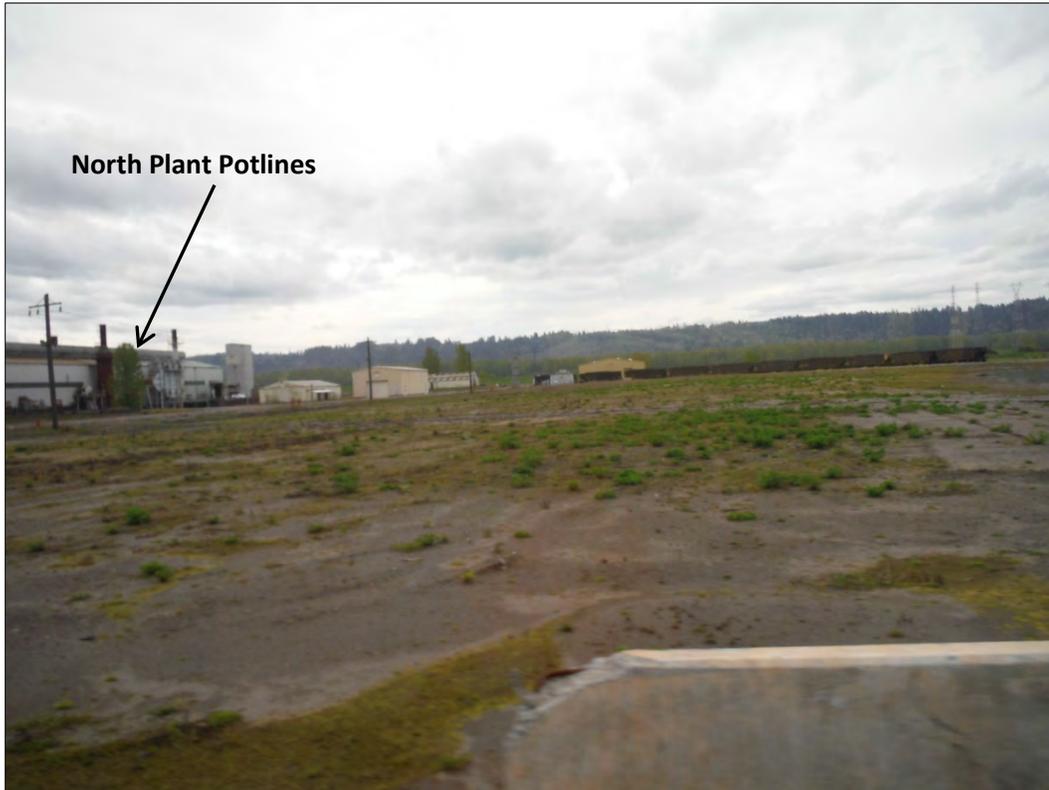
Photo 21. Photo shows typical disturbed vegetation cover type in central portion of Outdoor Storage Area between the Cable Plant and North Plant Potlines on the MBTL Site. (Photo Date: 4/8/2014)

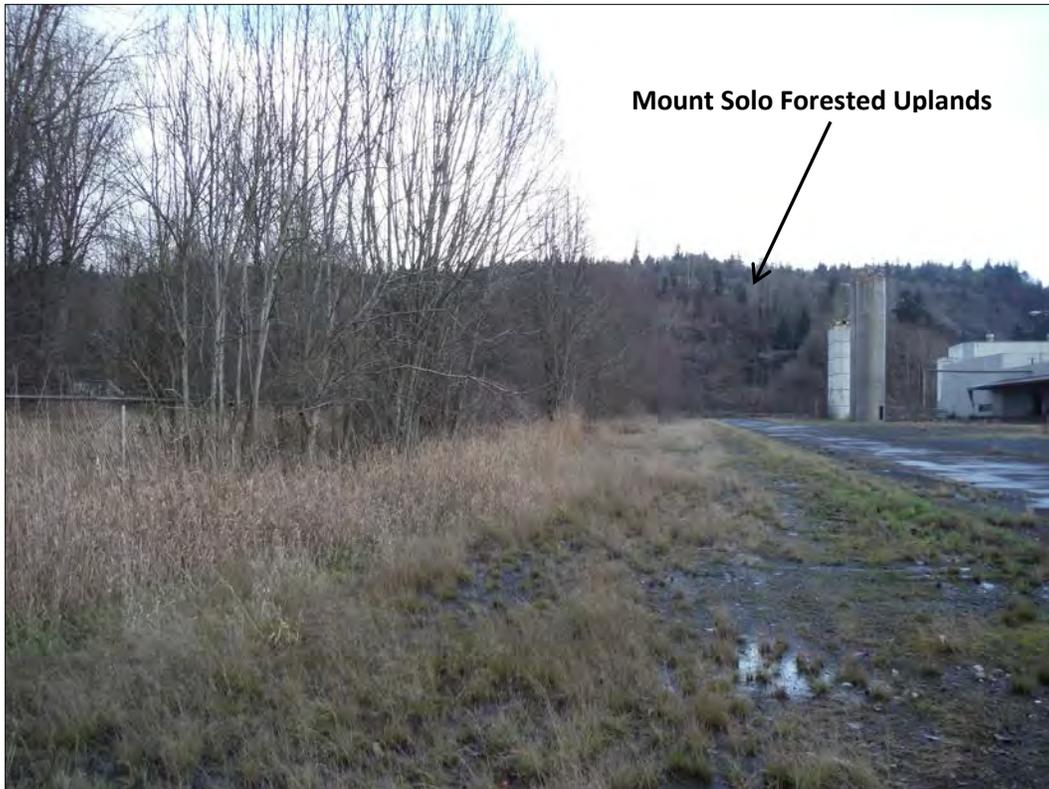
Photo 22. Photo shows upland scrub-shrub cover type along the edge of the former Cable Plant parking lot on the MBTL Site. Parking lot and Cable Plant are classified as disturbed lands. Forested uplands on Mount Solo are visible in the background. (Photo Date: 12/12/2014)

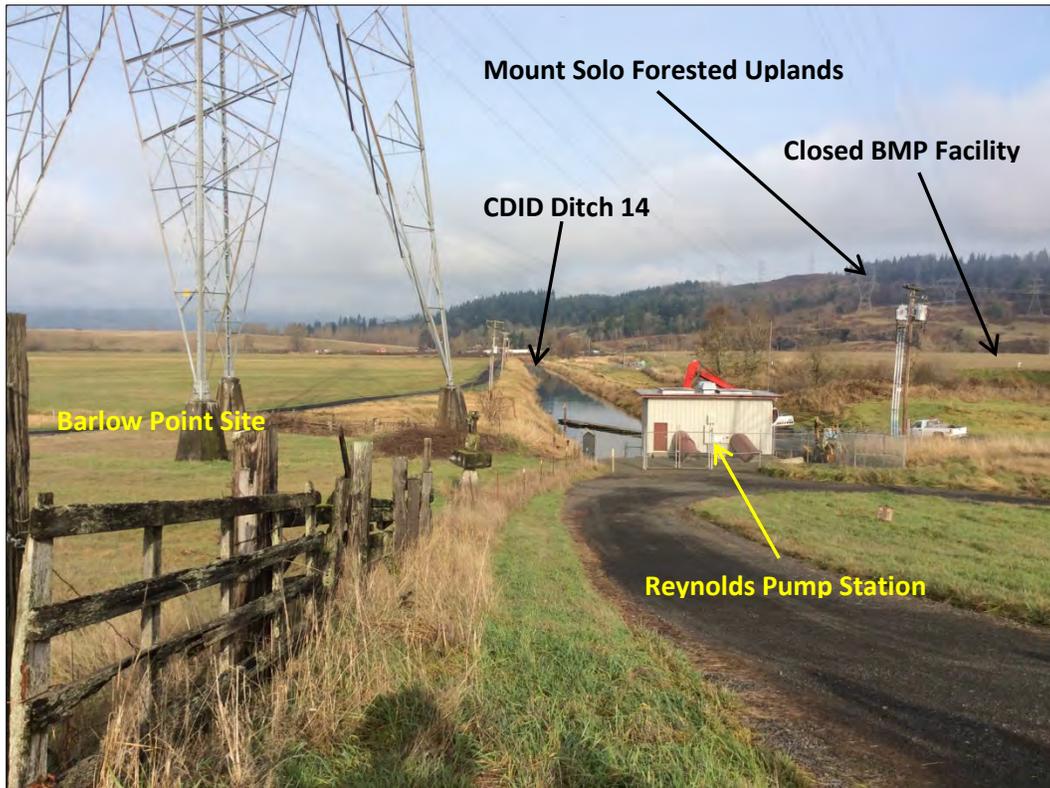
Photo 23. Photo shows CDID's Reynolds Pump Station and CDID Ditch 14 on the MBTL Site. Forested uplands of Mount Solo are visible in the background (Photo Date: 12/12/2014)

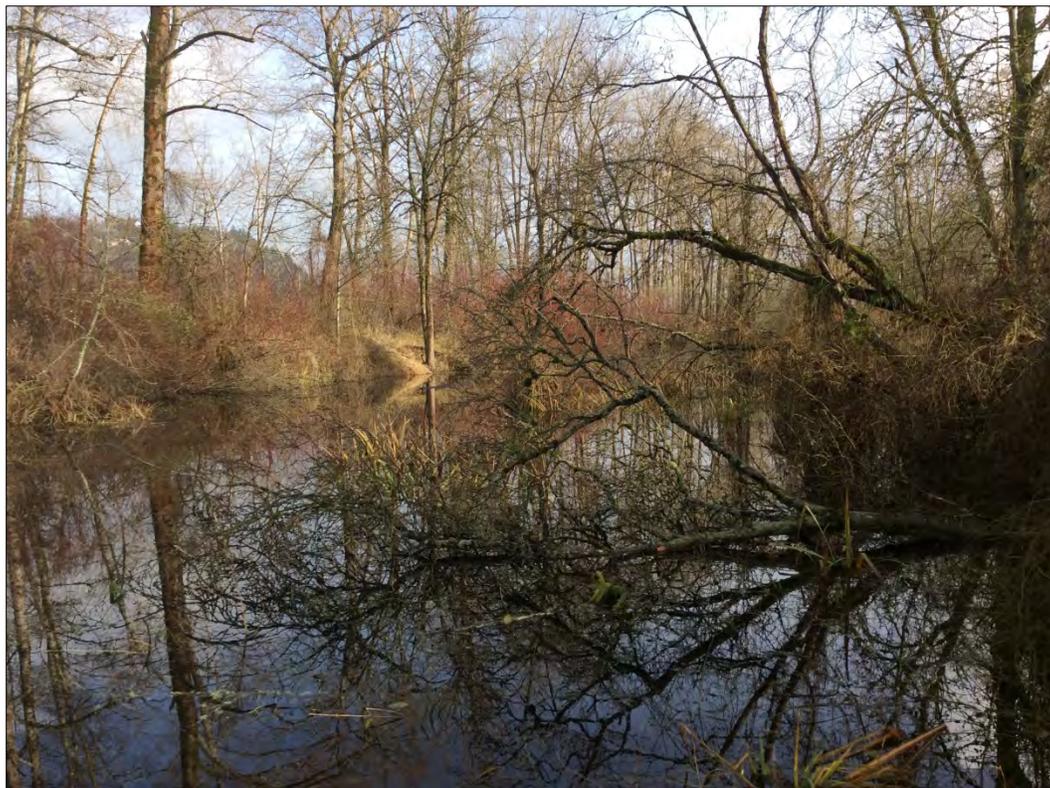
Photo 24. Photo shows typical forested upland vegetation along the south channel of the U-Ditch on the MBTL Site. (Photo Date: 12/12/2014)

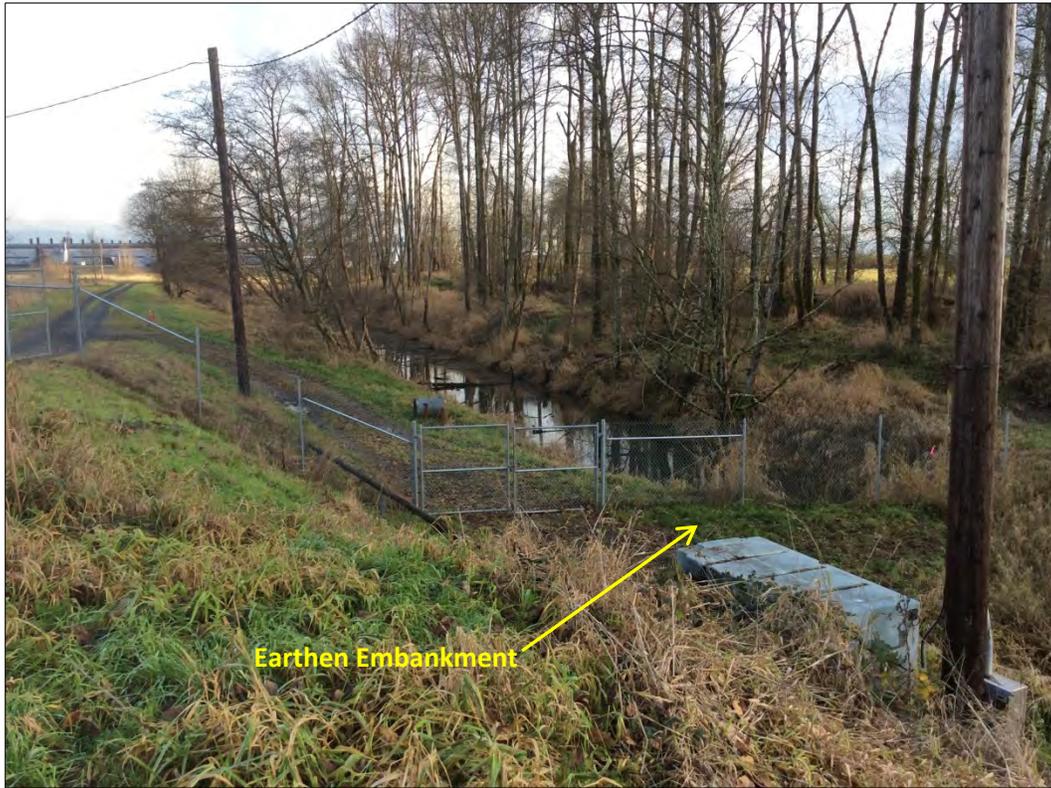
Photo 25. Photo shows forested uplands adjacent to the north channel of the U-Ditch on the MBTL Site. The earthen embankment that separates the U-Ditch from the Interception Ditch is visible on the right. (Photo Date: 12/12/2014)

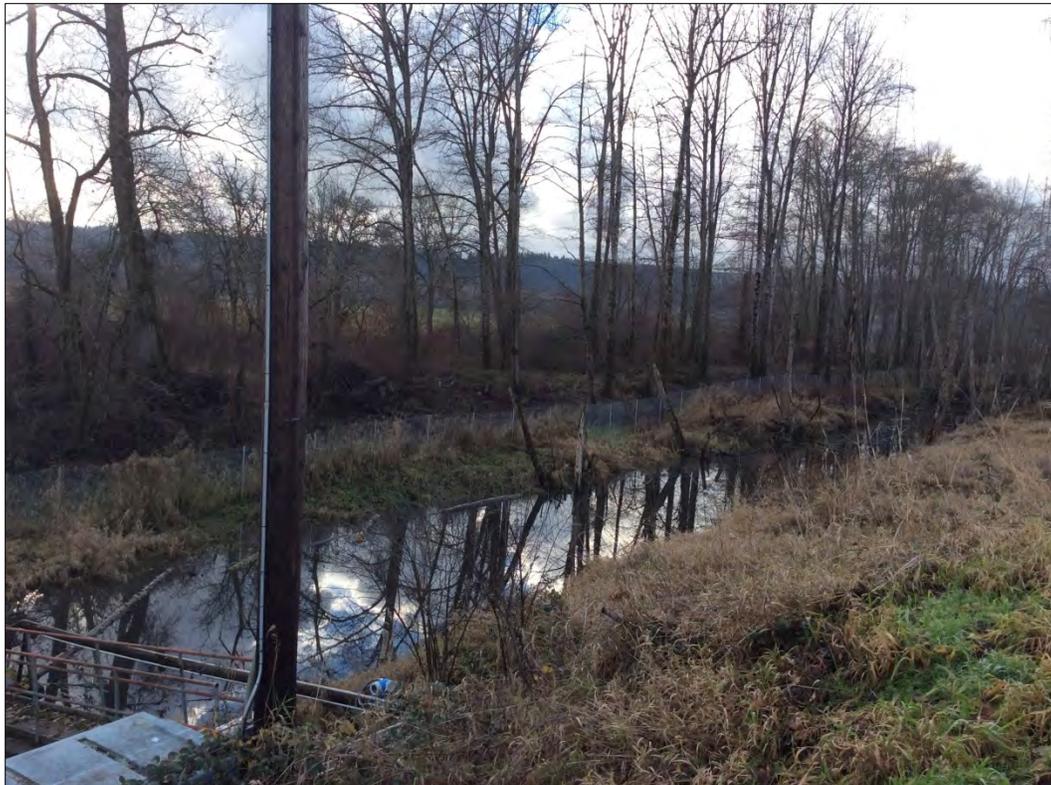
Photo 26. Photo shows forested uplands along the Interception Ditch, which lies to the south of the Closed BMP Facility on the MBTL Site. (Photo Date: 12/12/2014)
