MILLENNIUM BULK TERMINALS—LONGVIEW SEPA ENVIRONMENTAL IMPACT STATEMENT

SEPA VEGETATION TECHNICAL REPORT

April 2016

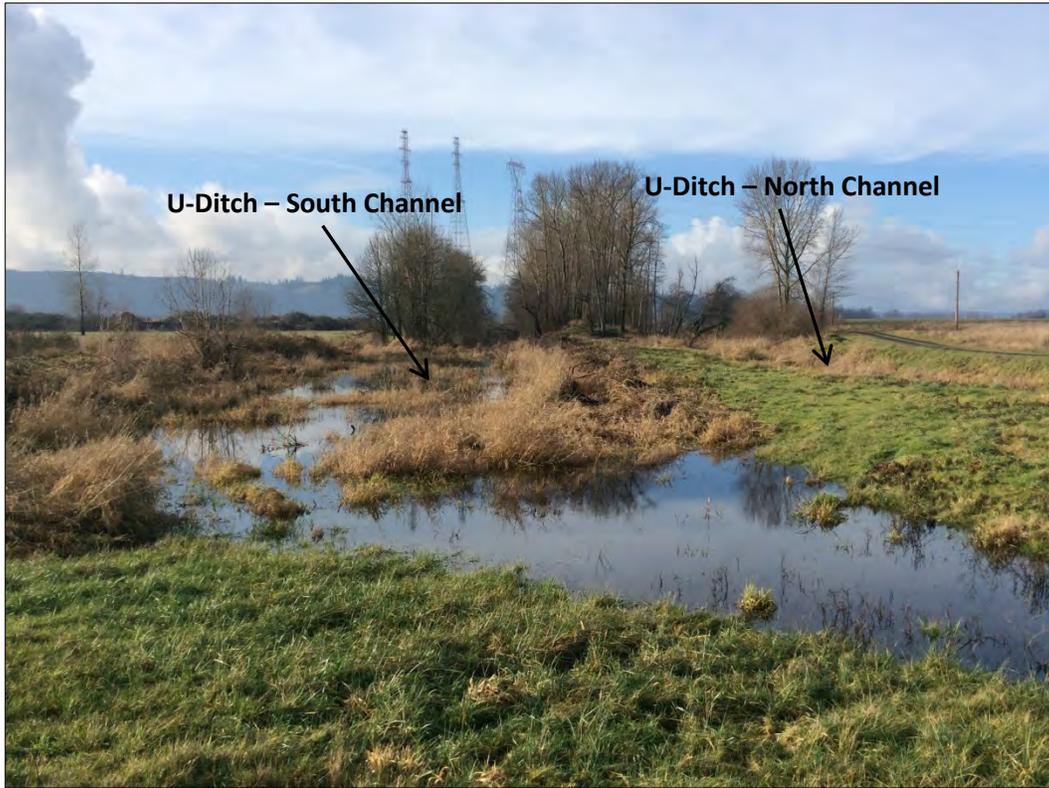
Photo 27. Photo shows typical vegetation present around the western end of the U-Ditch near the confluence of the north and south channels on the MBTL Site. (Photo Date: 12/12/2014)

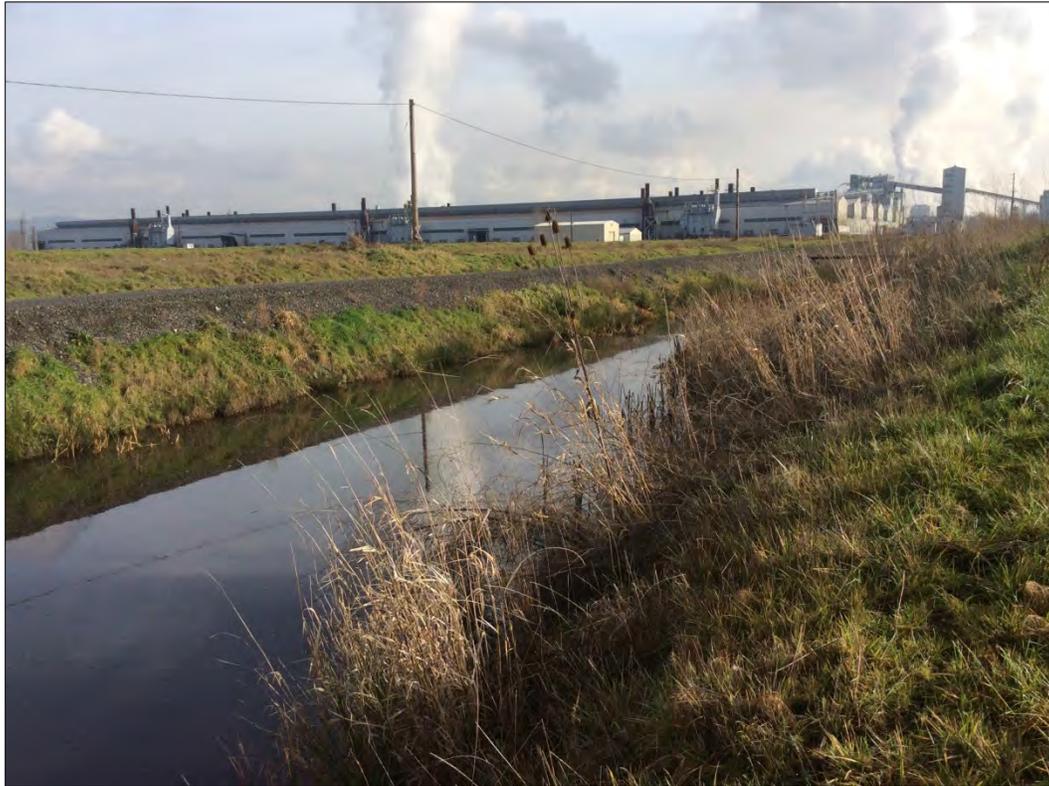
Photo 28. Photo shows combined channel of the U-Ditch that flows to the stormwater treat facility on the MBTL Site. Adjacent areas are classified as the disturbed cover type (Photo Date: 12/12/2014)

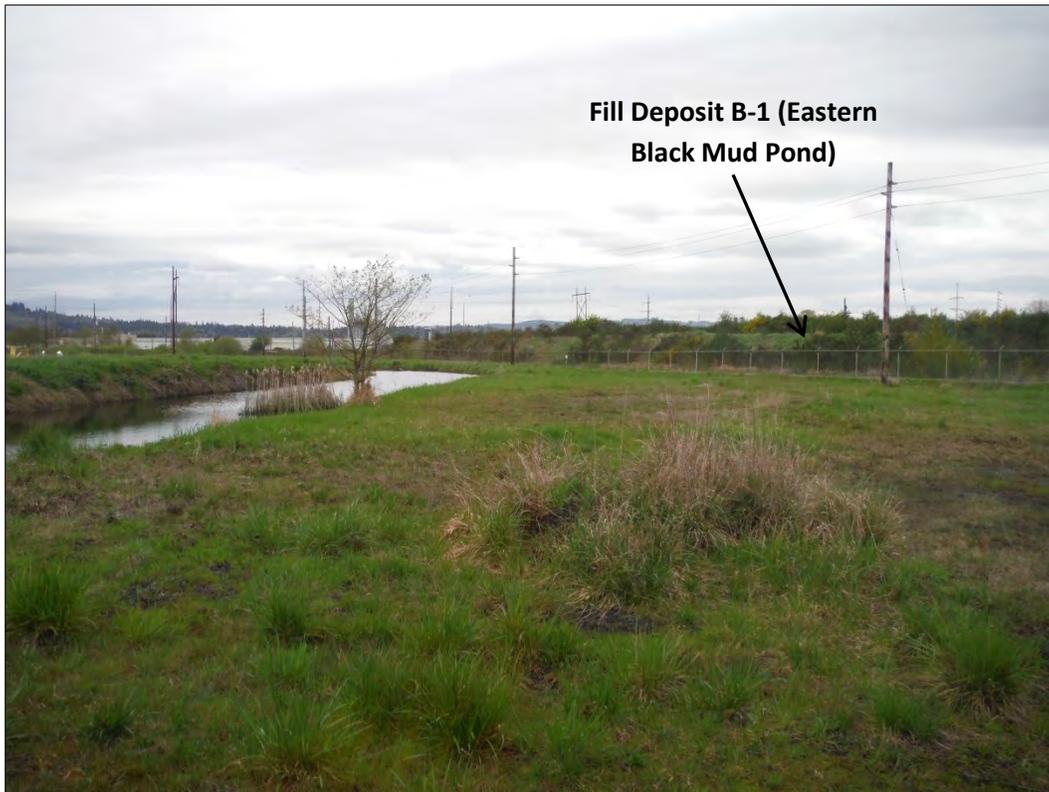
Photo 29. Photo shows typical disturbed vegetation cover type growing around one of the Cryolite Recovery Ditches on the MBTL site. Fill Deposit B-1 (Eastern Black Mud Pond) can be seen in background. (Photo Date: 4/8/2014)

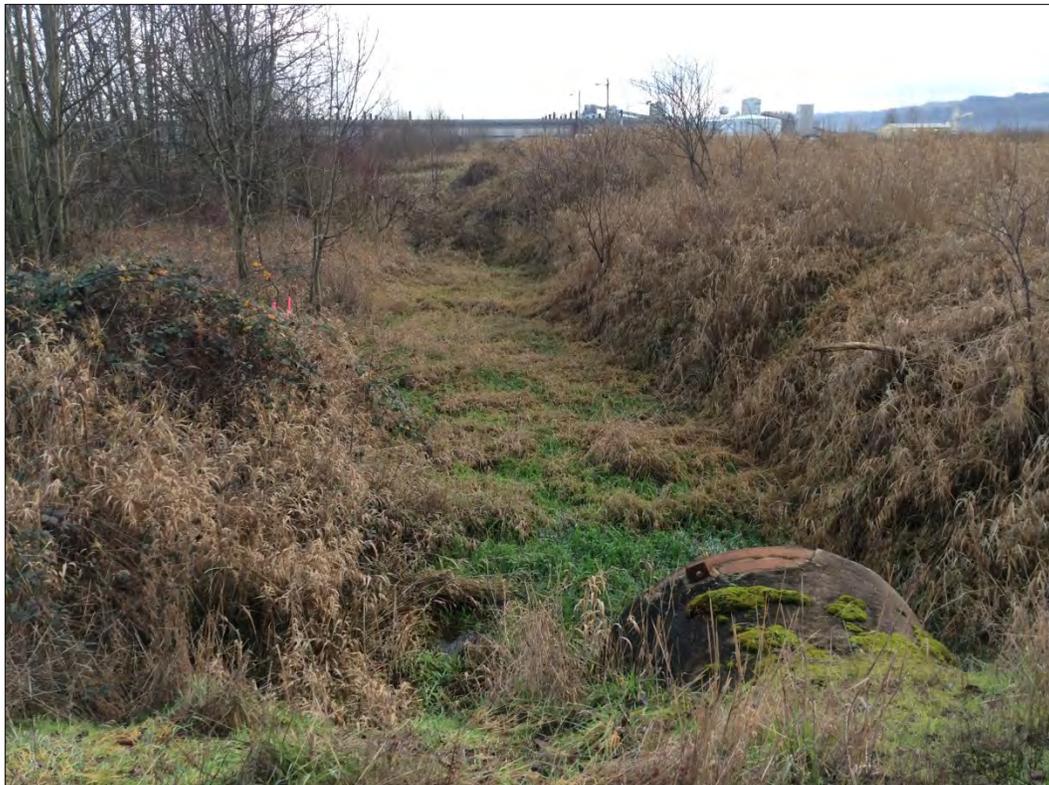
Photo 30. Photo shows unnamed stormwater conveyance ditch to south of Cable Plant on MBTL Site. This ditch flows through Remnant Forest Area and into Wetland Y. (Photo Date: 12/12/2014)

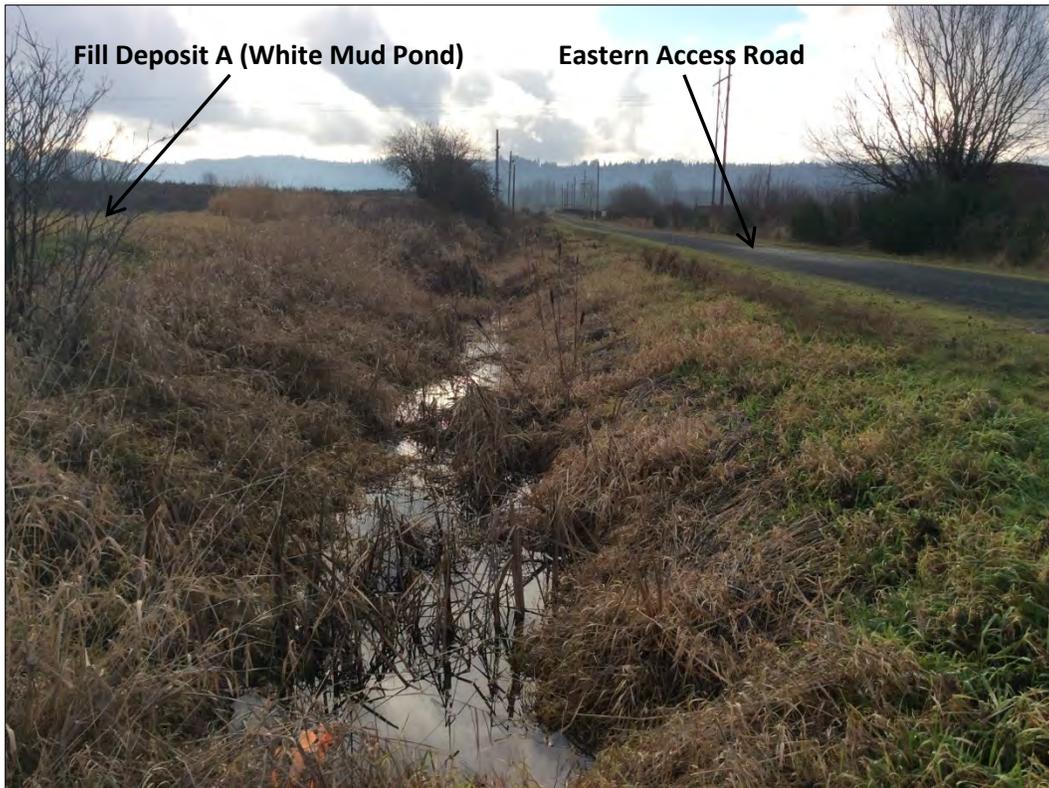
Photo 31 Photo show vegetation in a roadside ditch between Fill Deposit A (White Mud Pond) and the eastern access road. This area is mapped as an herbaceous upland cover type. (Photo Date: 12/12/2014)

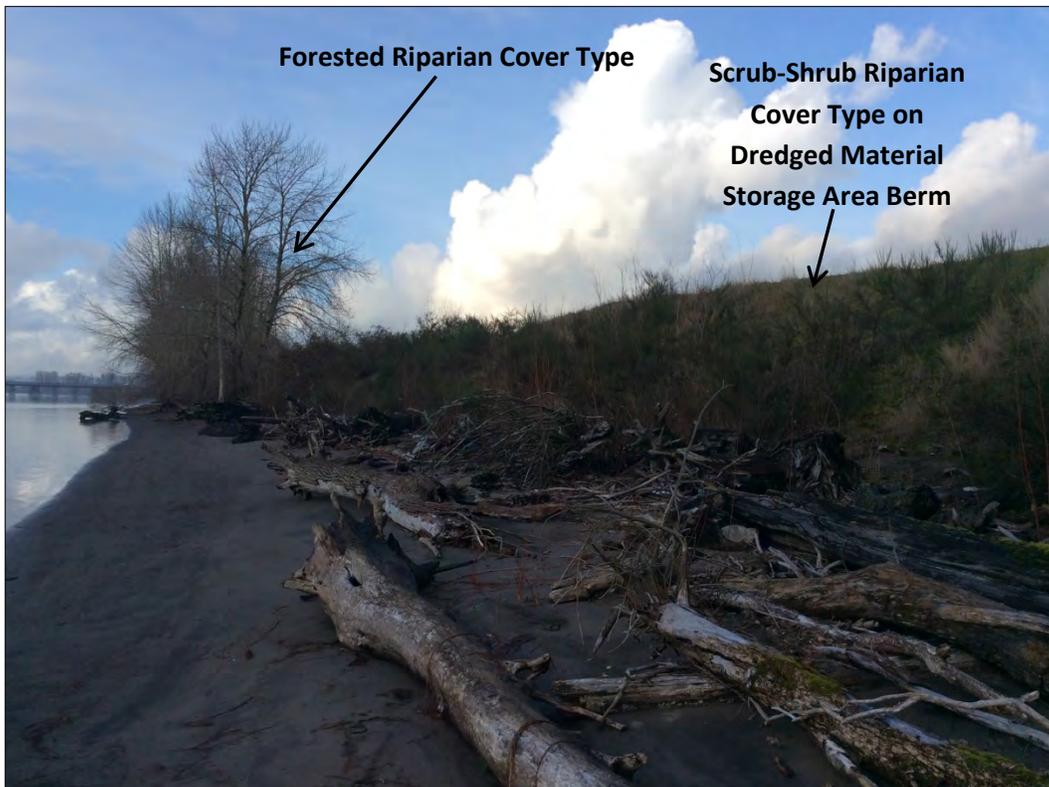
Photo 32. Photo shows typical conditions present along the southern shoreline of the MBTL Site including the scrub-shrub riparian cover type on the berm around the Dredged Material Disposal Area and a forested riparian area. (Photo Date: 12/12/2014)

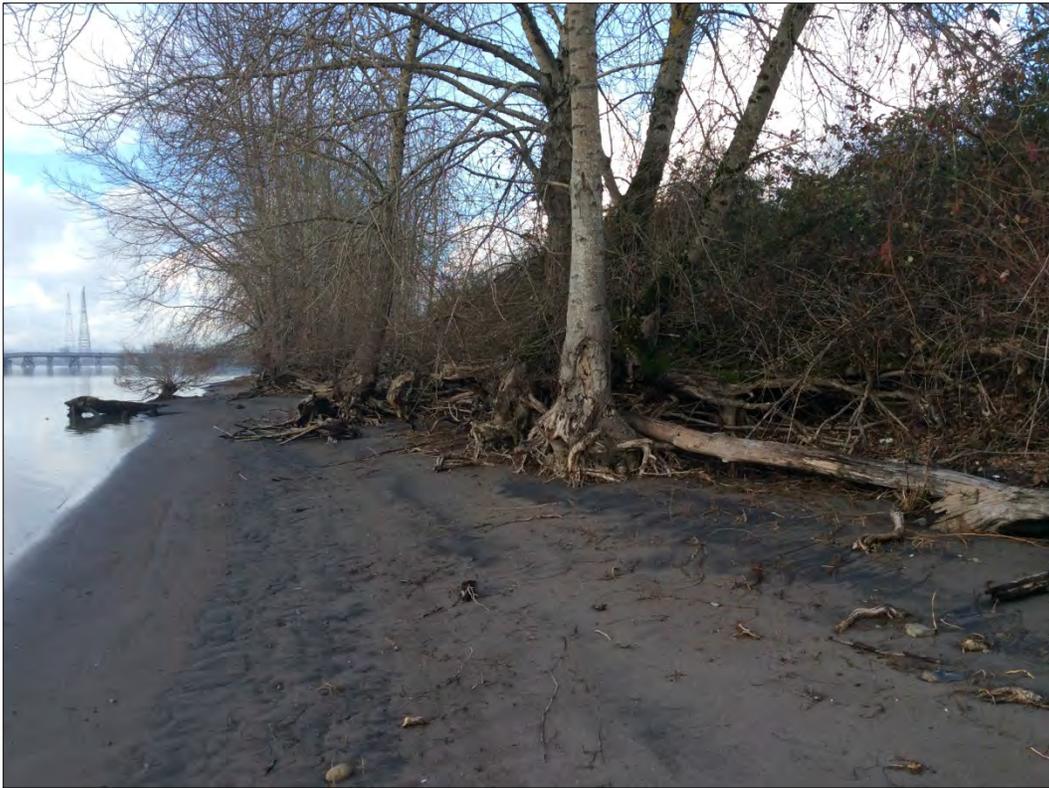
Photo 33. Photo shows forested riparian cover type along southern portion of the MBTL Site shoreline. (Photo Date: 12/12/2014)

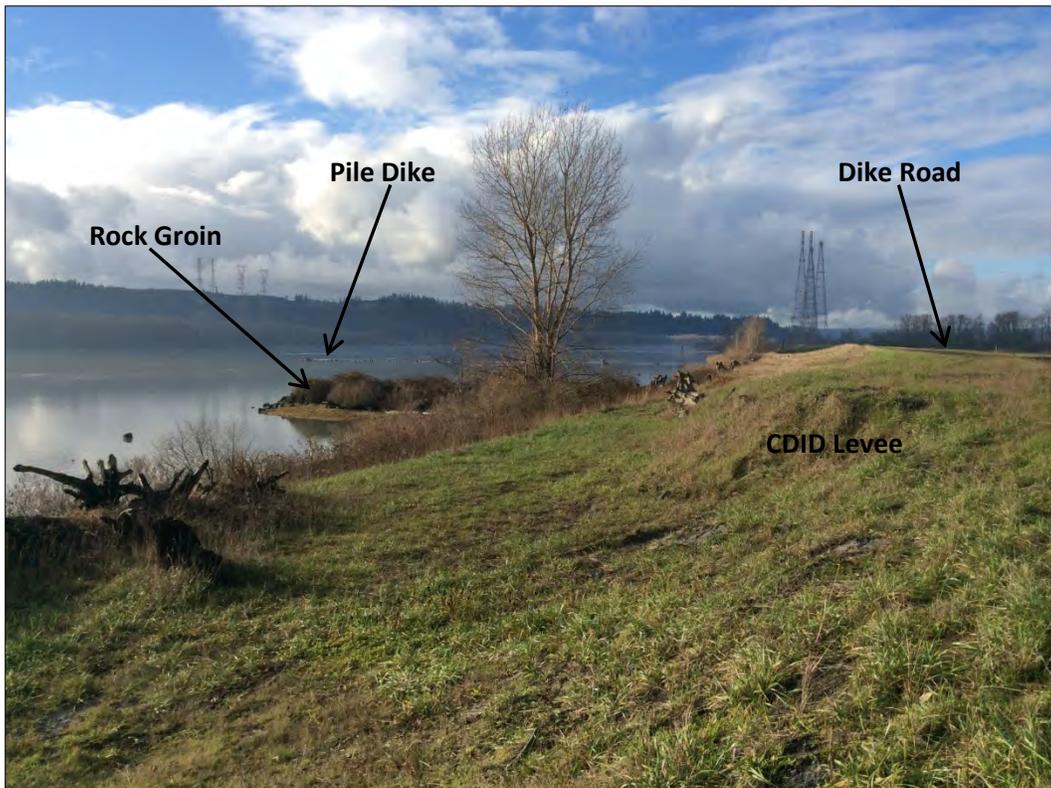
Photo 34. Photo shows typical managed herbaceous vegetation cover type growing on the river side of the CDID Columbia River Levee. Existing rock groin and pile dikes are also visible. (Photo Date: 12/12/2014)

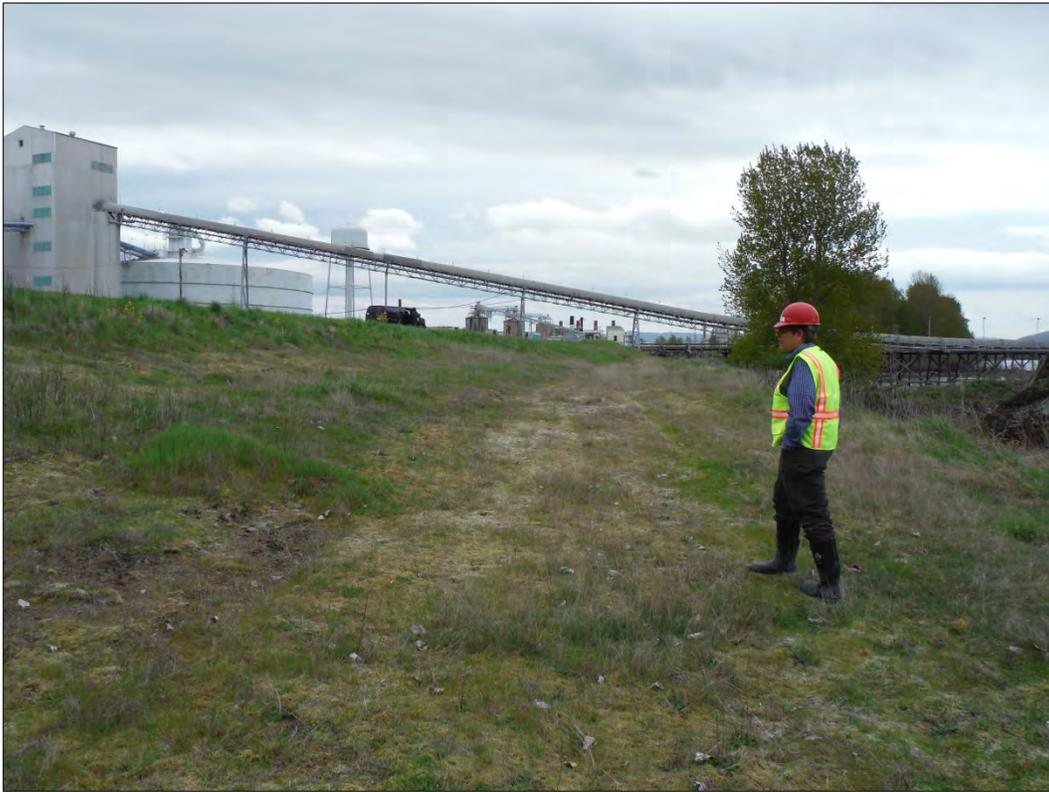
Photo 35. Photo shows typical managed herbaceous vegetation cover type growing on the river side of the CDID Columbia River Levee downstream of the existing Dock 1 conveyor and trestle on the MBTL Site. Forested riparian areas are also shown. (Photo Date: 4/8/2014)

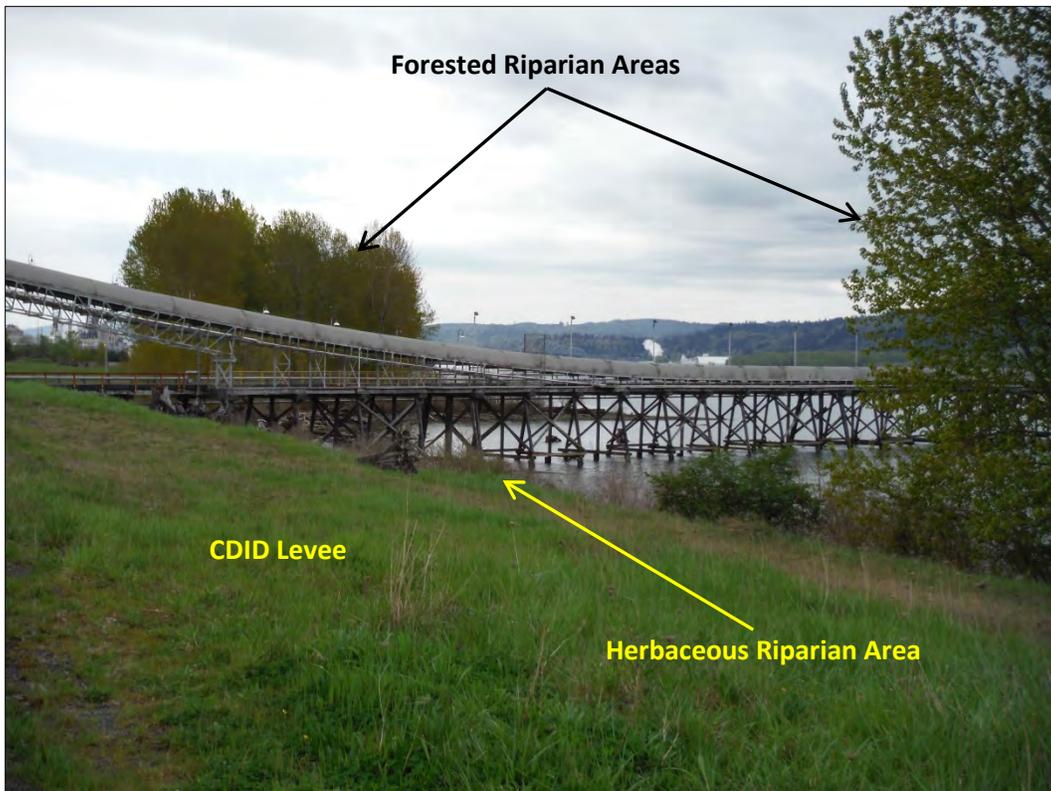
Photo 36. Photo shows typical managed herbaceous vegetation cover type growing on the river side of the CDID Columbia River Levee and in the vicinity of the existing Dock 1 conveyor and trestle on the MBTL Site. Forested riparian vegetation cover types are also shown (Photo Date: 4/8/2014)

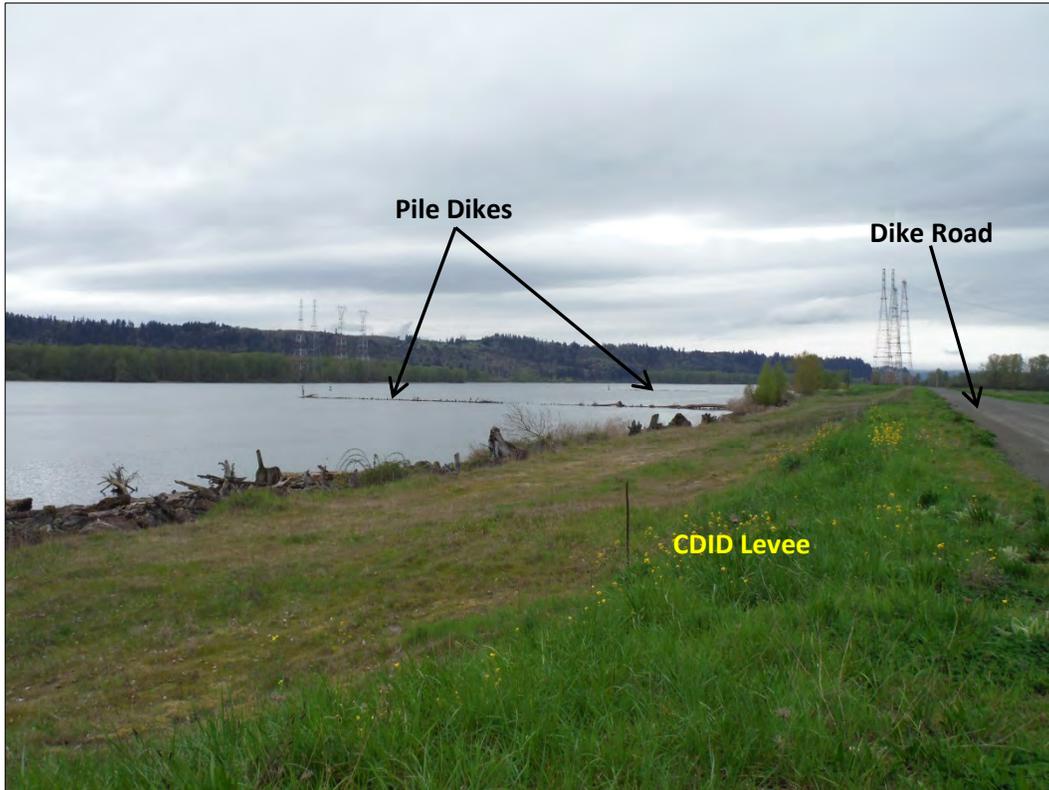
Photo 37. Photo shows typical managed herbaceous vegetation cover type growing on the river side of the CDID Columbia River Levee and herbaceous riparian area along shoreline. Existing pile dikes are also visible. (Photo Date: 4/8/2014)

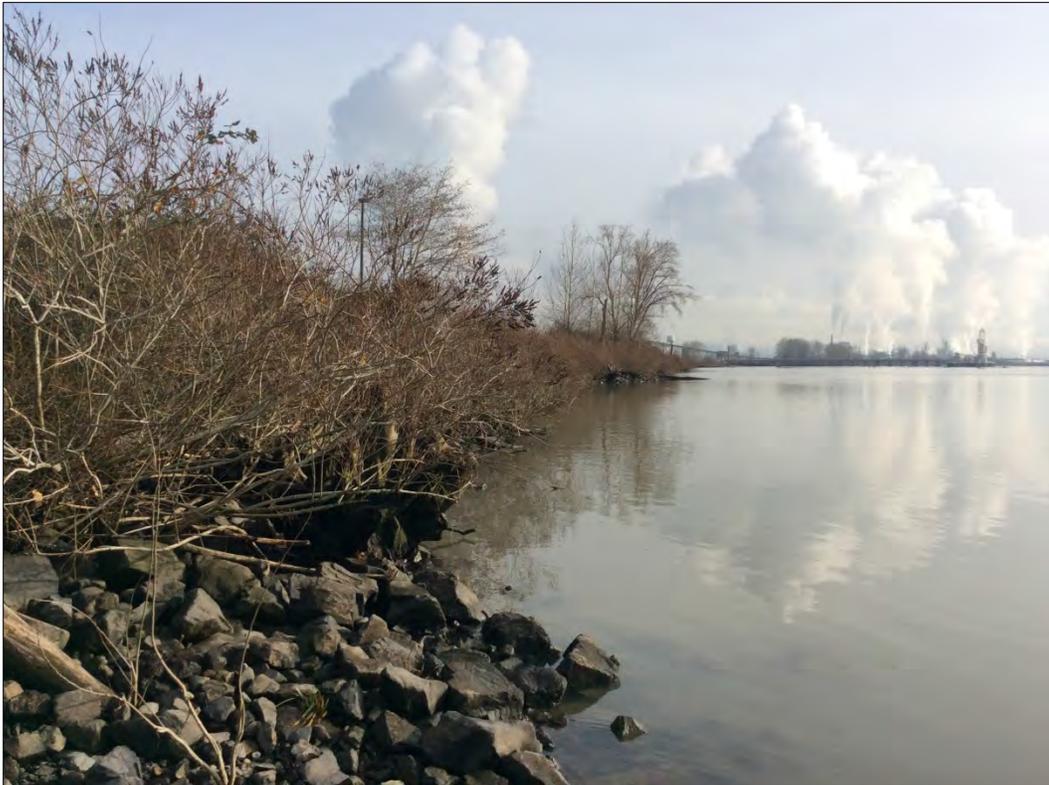
Photo 38. Photo shows typical conditions present along the northern shoreline of the MBTL Site near the CDID Reynolds Pump Station outfall. (Photo Date: 12/12/2014)

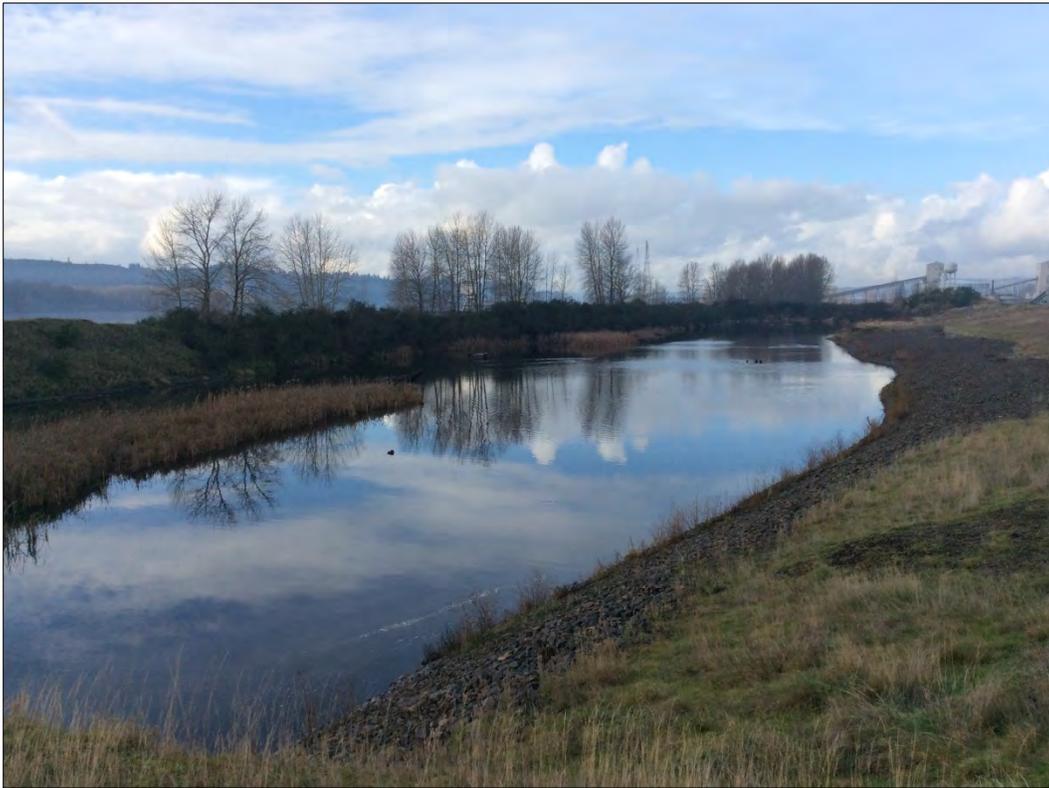
Photo 39. Photo shows the typical conditions present in the Dredged Material Storage Area on the MBTL Site. (Photo Date: 12/12/2014)

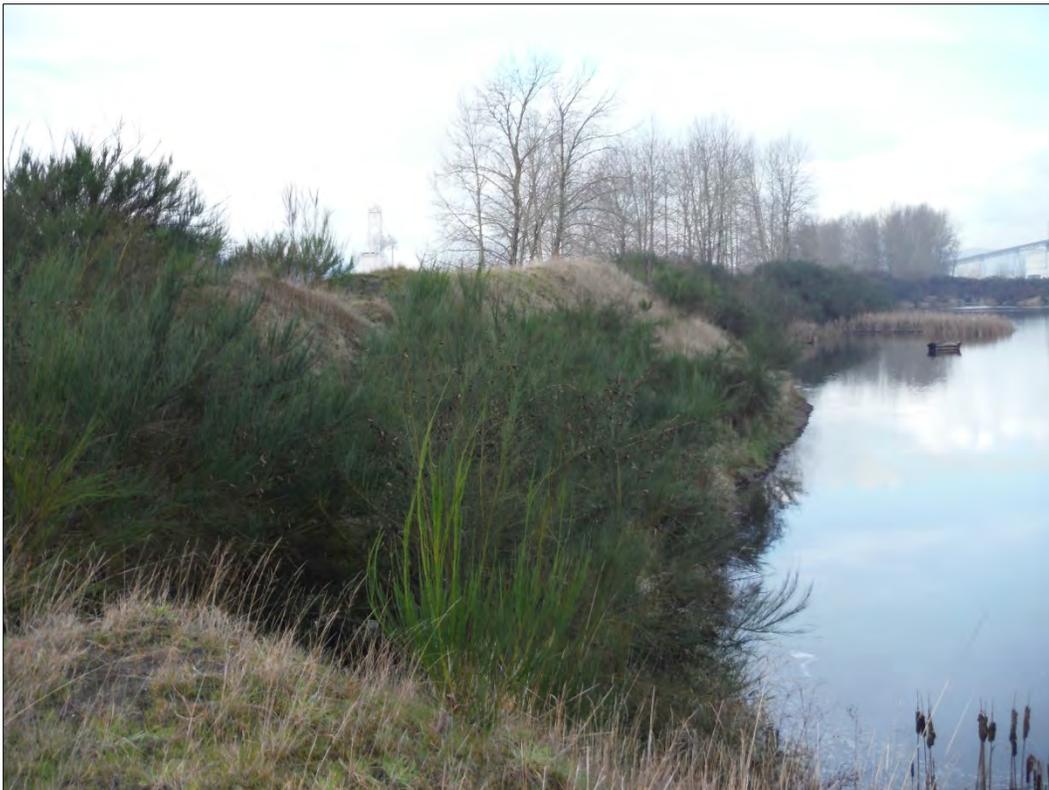
Photo 40. Photo shows typical vegetation growing on the landward side of the berm around the Dredged Material Storage Area on the MBTL site. This area was classified as scrub-shrub riparian (Photo Date: 12/12/2014)

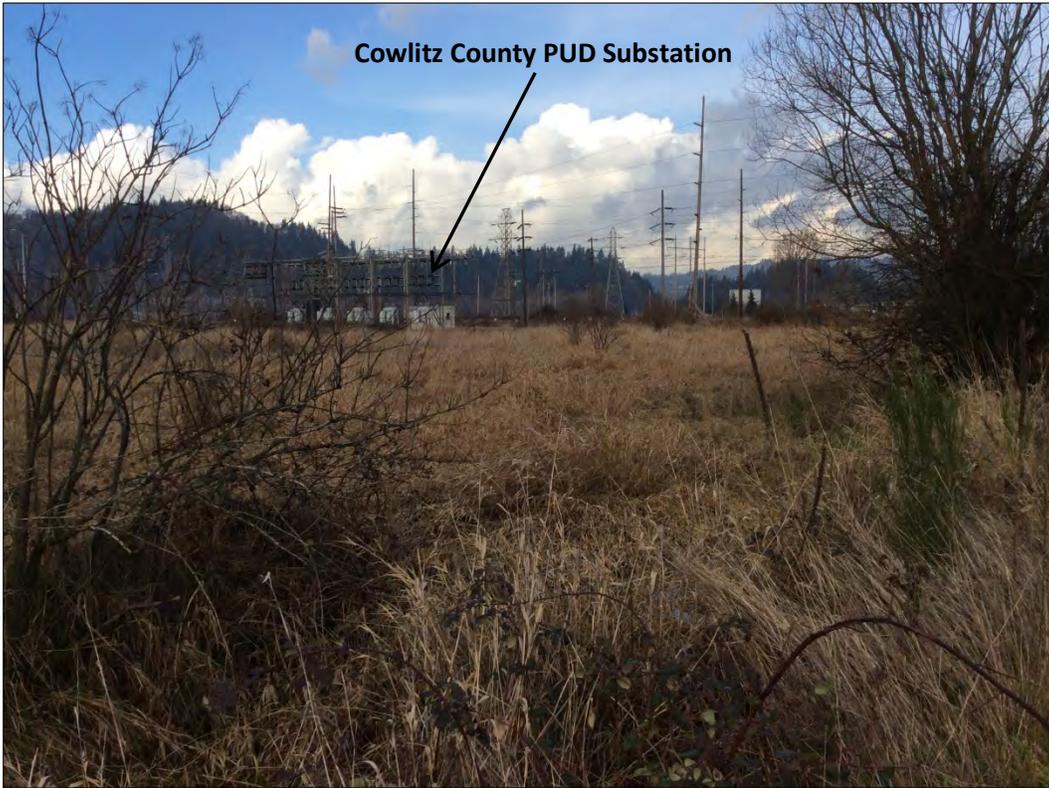
Photo 41. Photo shows typical herbaceous wetland vegetation cover type in the northern portion of Wetland E on Parcel 61954 of the MBTL Site (Photo Date: 12/12/2014)

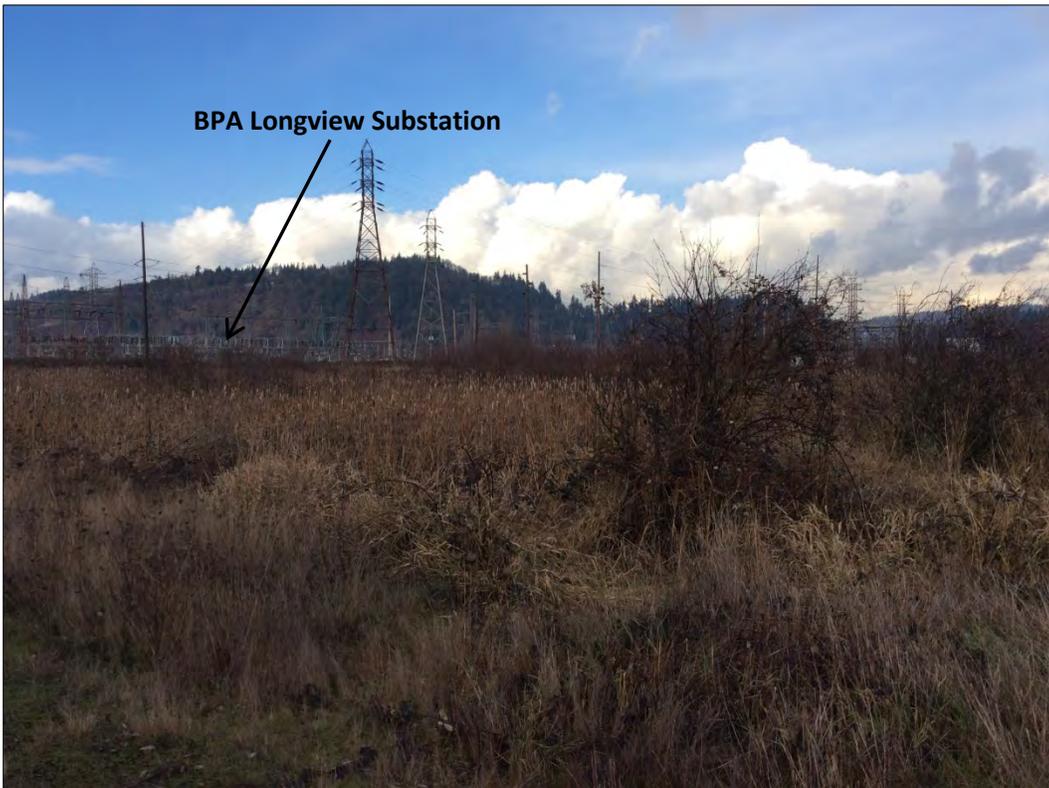
Photo 42. Photo shows typical herbaceous wetland vegetation cover type in the southern portion of Wetland E on Parcel 61954 of the MBTL Site (Photo Date: 12/12/2014)

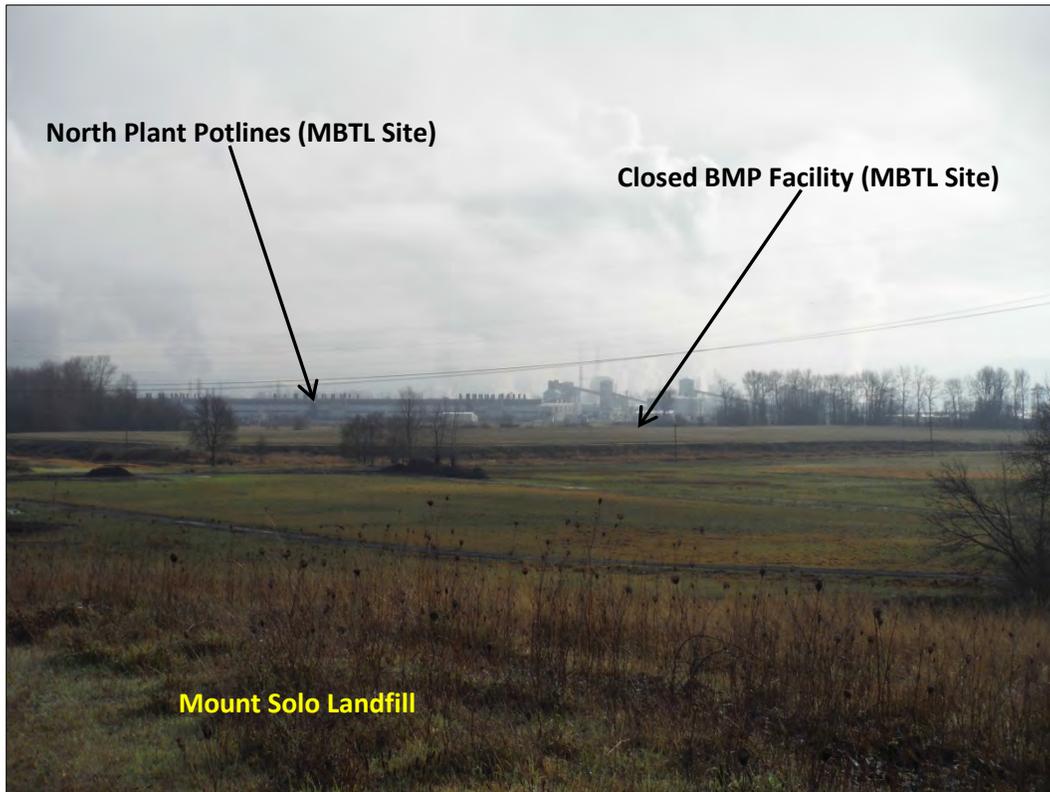
Photo 43. Photo shows disturbed, herbaceous upland, managed herbaceous upland, and herbaceous wetland cover types present in the southern portion of Barlow Point Site, as viewed from the Mount Solo Landfill. Wetlands 3 and 5 are present in the center of the photo but are not readily discernable. (Photo Date: 12/12/2014)

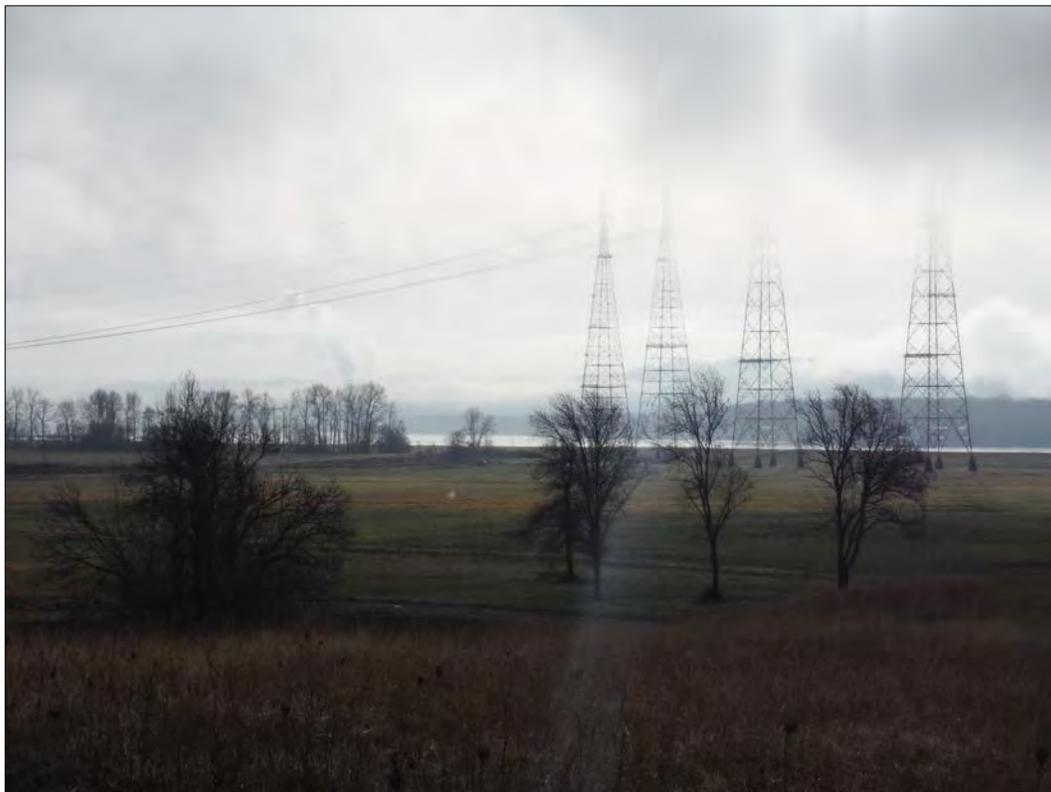
Photo 44. Photo shows disturbed, herbaceous upland, managed herbaceous upland, and herbaceous wetland cover types present in the southern portion of Barlow Point Site, as viewed from the Mount Solo Landfill. (Photo Date: 12/12/2014)

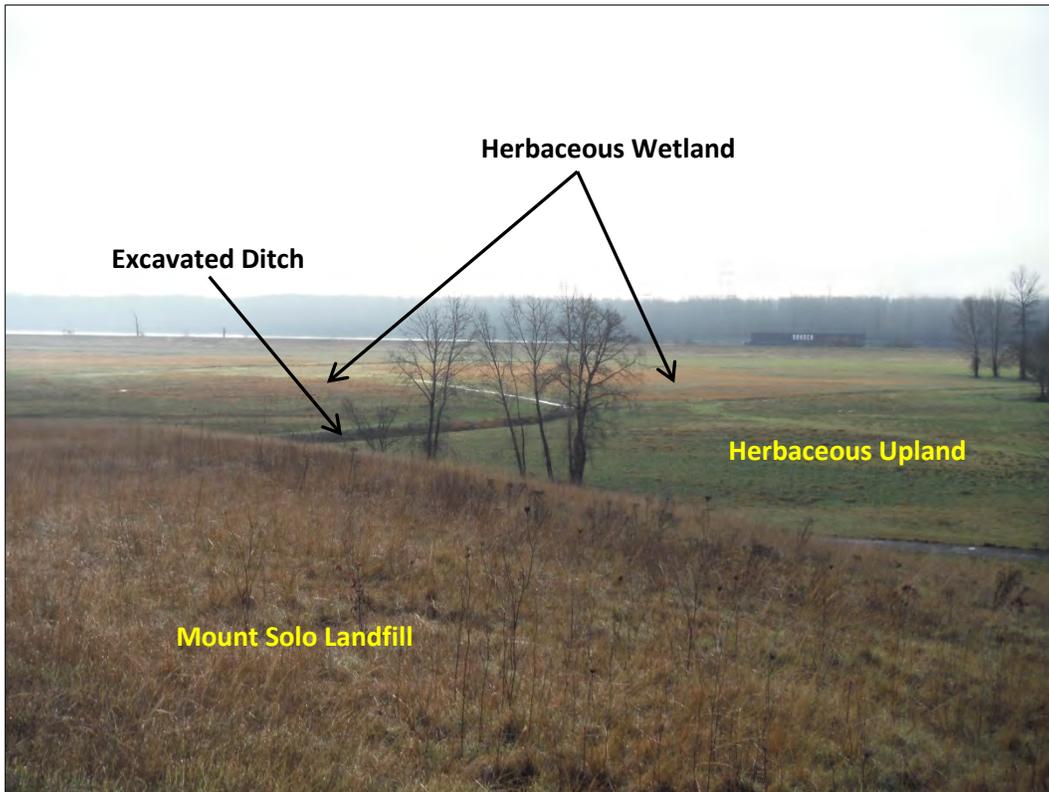
Photo 45. Photo shows disturbed, herbaceous upland, managed herbaceous upland, and herbaceous wetland cover types present in the southern portion of Barlow Point Site, as viewed from the Mount Solo Landfill. Wetland 4 is present on both sides of the excavated ditch. (Photo Date: 12/12/2014)
